SMITHS FALLS
RISE AT THE FALLS

G. Douglas Vallee Limited

Heritage Building Structural Pathology Engineering Report

25 Old Mill Road
Town of Smiths Falls

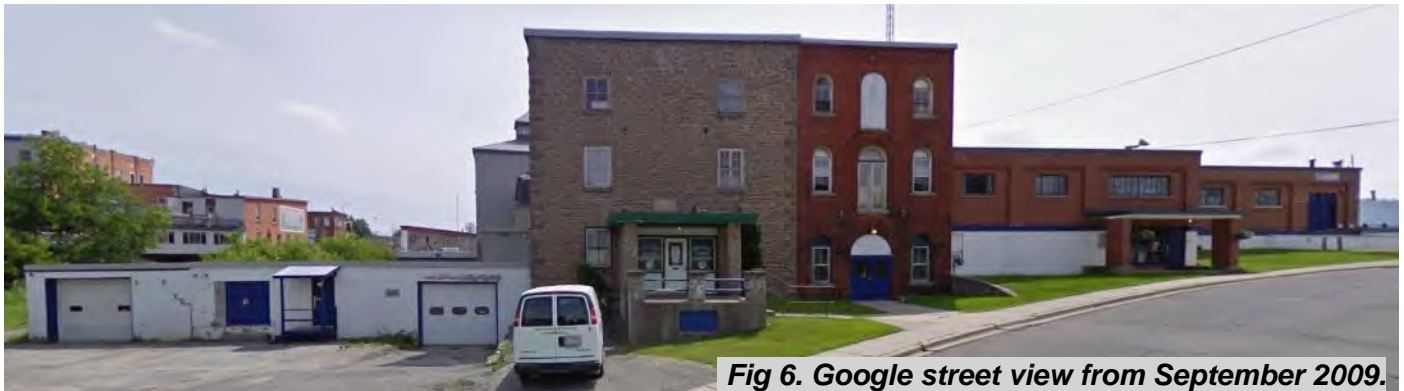
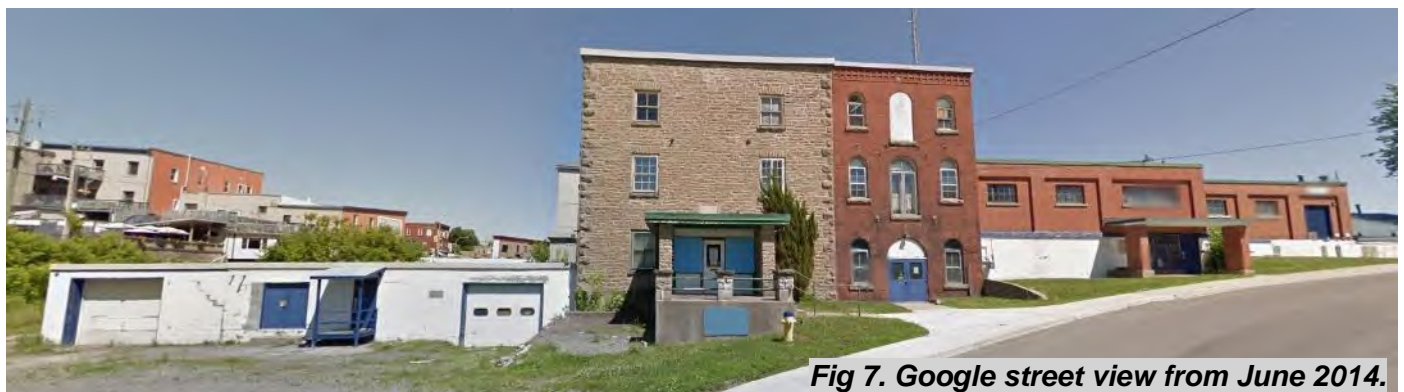
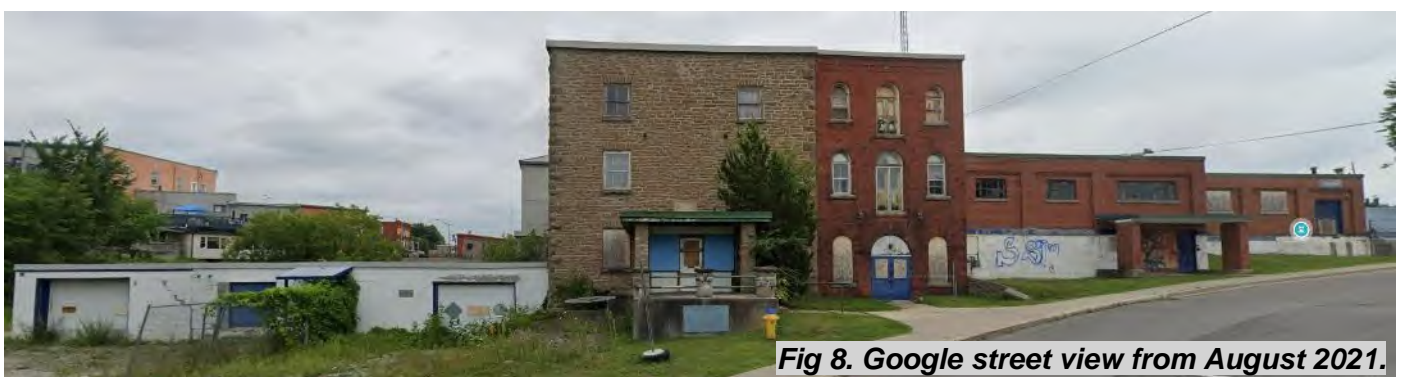
To visualize the rate of change in condition for the vacated building, compare Fig. 6 when the building was in active use to Fig. 8 below. A chronology of the west façade over the last decade is illustrated below.

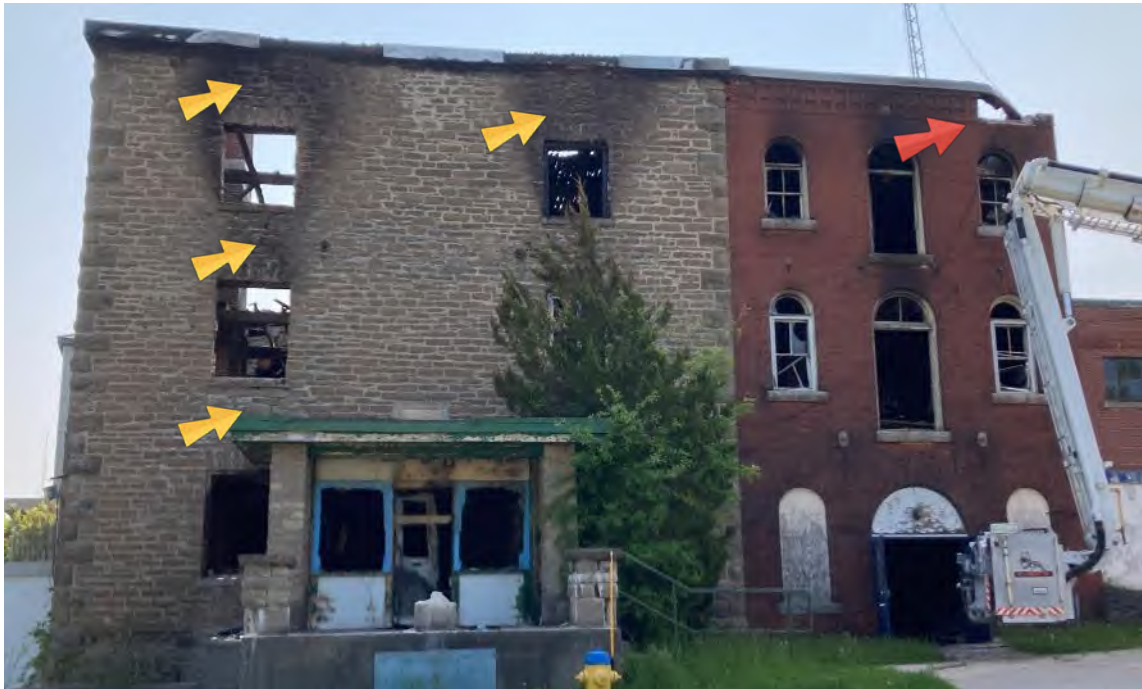
The following photographs illustrate the typical cracks seen in the front (west) face of the building. Areas that experienced direct exposure to flame heat and thermal shock from firefighting water experienced spalling of surficial repointed mortar. Parapet masonry typically experiences advanced deterioration due to exposure.

Fig 9. Note the appearance of post-fire cracks at RE2, 3E2, RE4 and parapet damage at RE8.

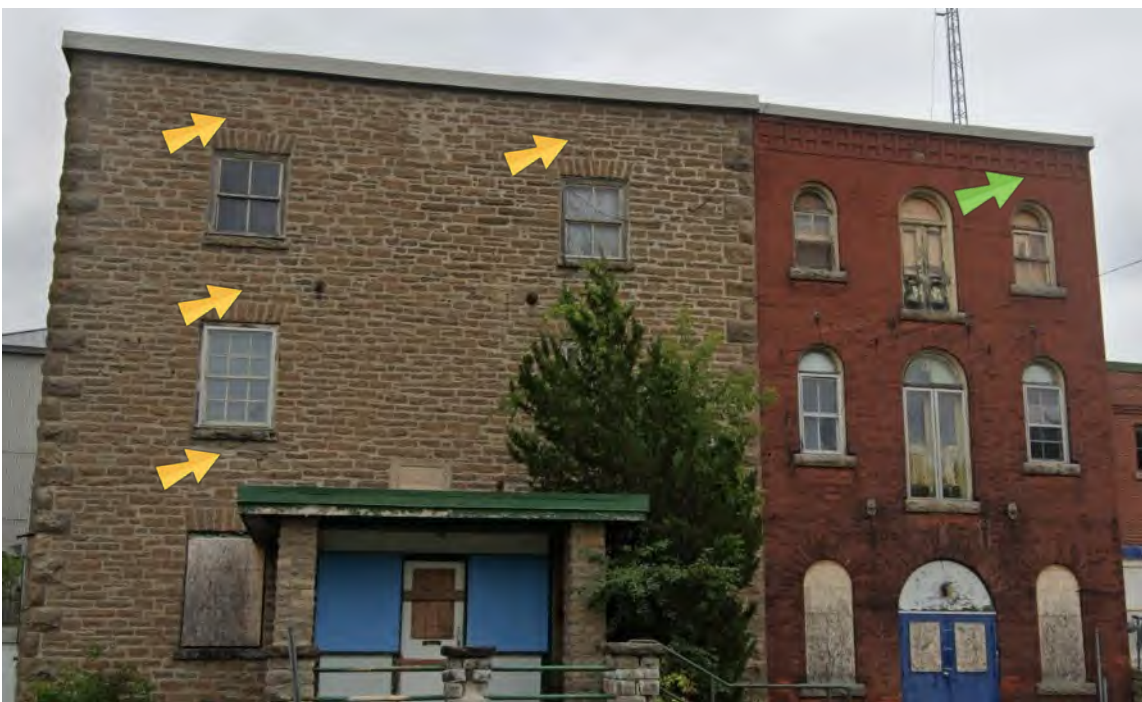
Fig 10. Note that mortar cracks at RE2, 3E2, 2E2, and RE4 existed before the fire.

Slight parapet concave and convex undulations noted at RE3 & RB1 in Figs. 10 & 11 appeared to be original to the building construction and not a result of the fire.

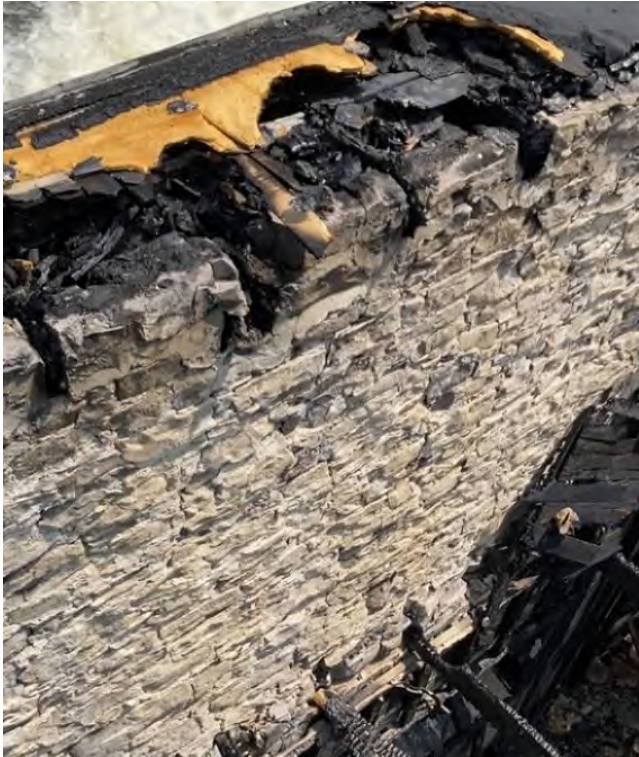
As seen below in Fig 12, the entirety of the timber floor and roof is destroyed by fire. The face of the wall exhibits similar degradation as noted on exterior faces that experienced direct exposure to flame heat and thermal shock from firefighting. The surficial mortar and parging experienced varying degrees of spalling in areas exposed to high thermal gradient, exposing the original lime mortar behind the surface. Arguably, the highest heat and thermal gradient shock would have occurred on the interior face of the rear (east) wall in the area from gridpoints A2-A4 at the 3rd level and roof.

Fig 12. Interior face of stone wall 3A2-3A4.

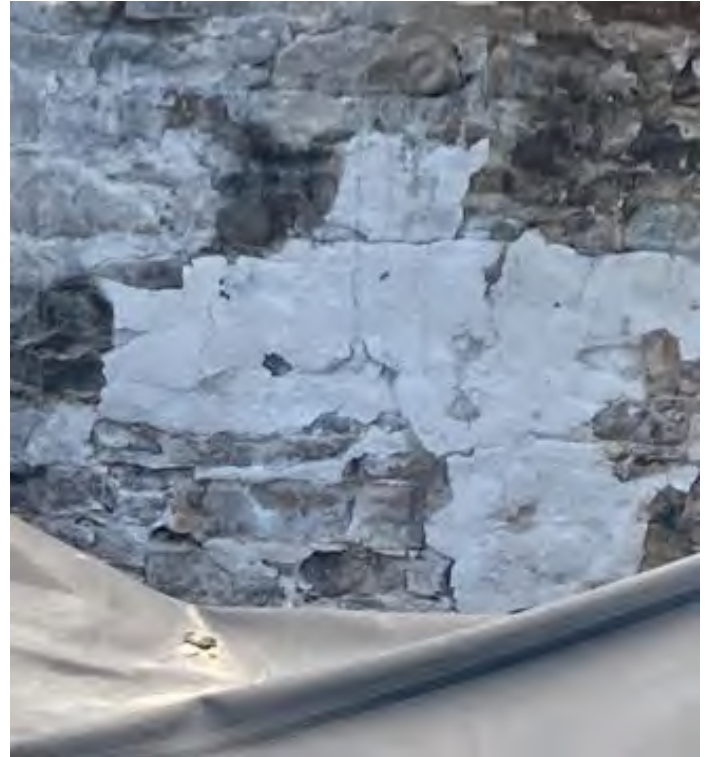
Fig 13. Plaster parging example at 3A5-3C5.

It is unclear if the white colour noted on some of the interior walls was due surficial mortar flushed down the wall face by firefighting or if it is remnant plaster, parging, or gypsum board. Plaster and parging was observed on the walls in various locations such as 3A5-3C5 and 3A8-3E8; gypsum drywall board is indicated in the provided drawings as part of the 1994 renovations.

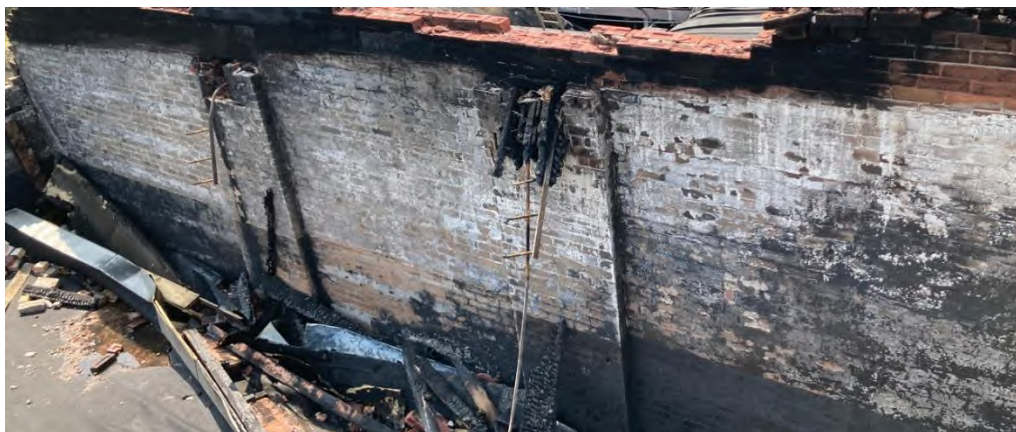
Fig 14. Plaster parging evident on the interior face of 3A8-3E8.

Depending on the location observed, the white residue is likely of these substances or a combination thereof.

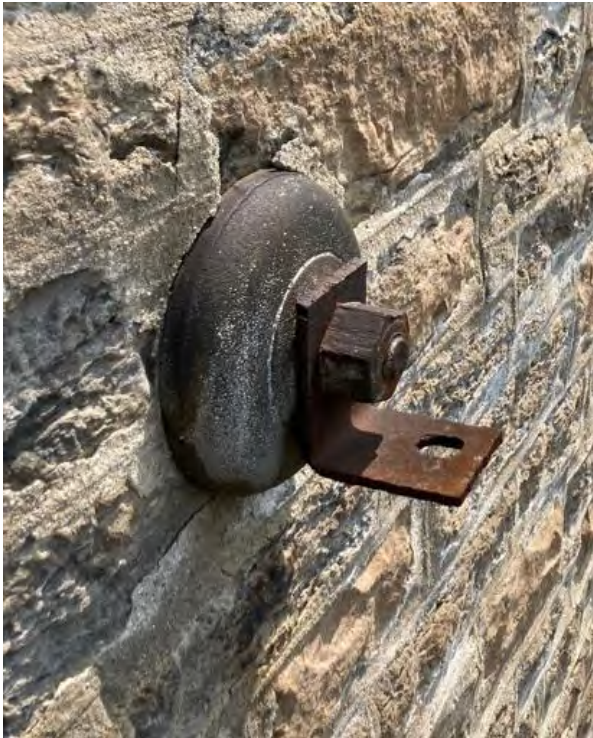
At various locations on the exterior faces of both Building 2 & 3, there are exterior plates with through-bolt tie-backs. In many cases for buildings of this vintage, these types of connections are typically used as a post-tensioned tie-back to prevent or arrest masonry wall displacements. In effect, the opposite function appears to the case here, whereas the interior floor structure renovations were tied into the stone walls for additional stability and anchorage. Upon examination of the provided structural design drawings, these appear to function more as anchorage for the interior renovation to the solid stone and masonry walls.

Fig 15. Through-bolt wall anchor at 3E2.

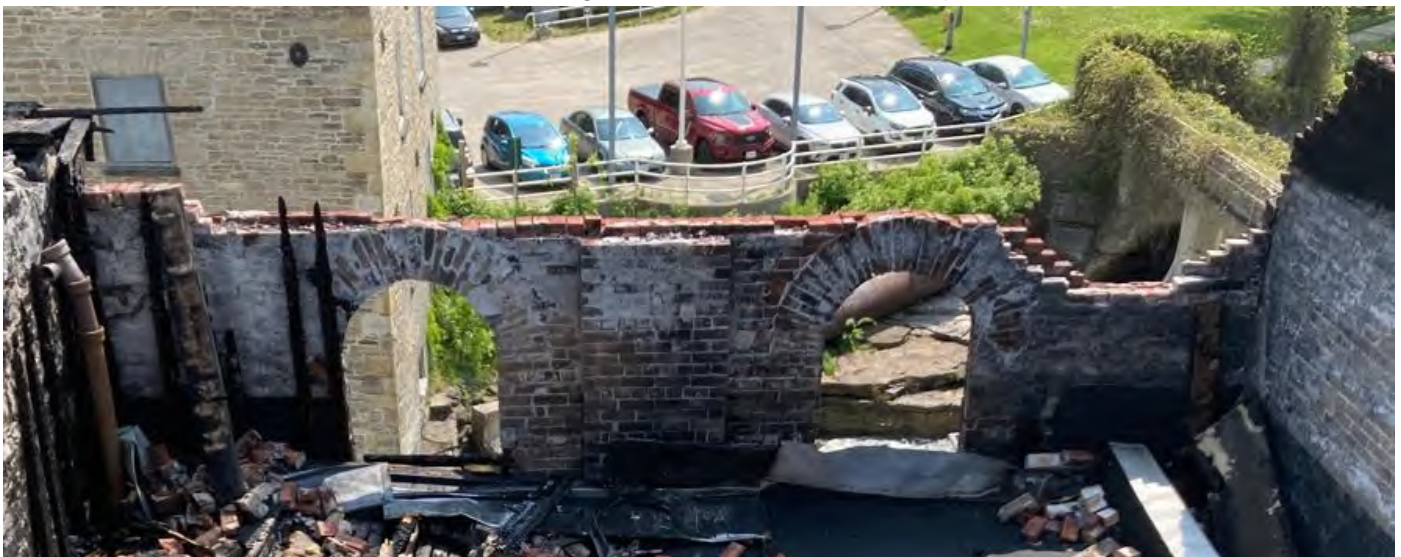
The parapet of the rear wall of Building 3 suffered extensive damage (RA5-RA8). The masonry arch lintels remain intact. Exterior views taken from Google Street View indicate the pre-fire condition of the rear wall.

Fig 19. View of Building 3 rear wall at 3rd level along the roof line (RA5-RA8).

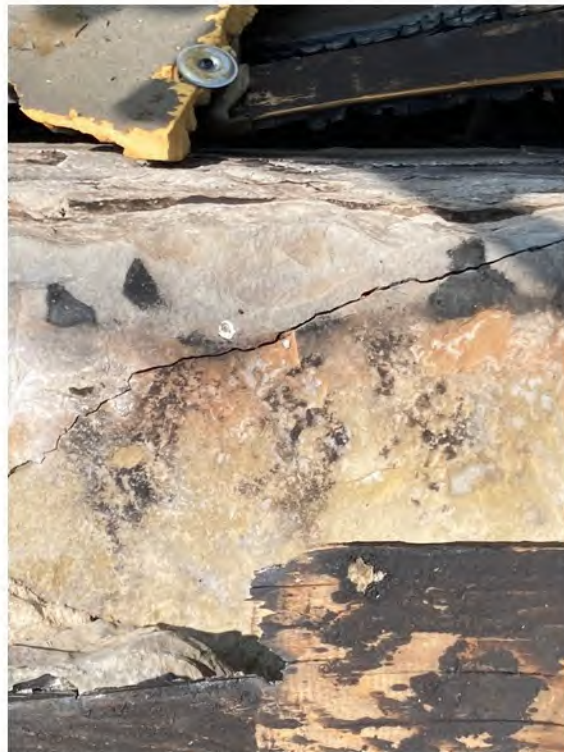
RC5 Parapet sandstone fissure

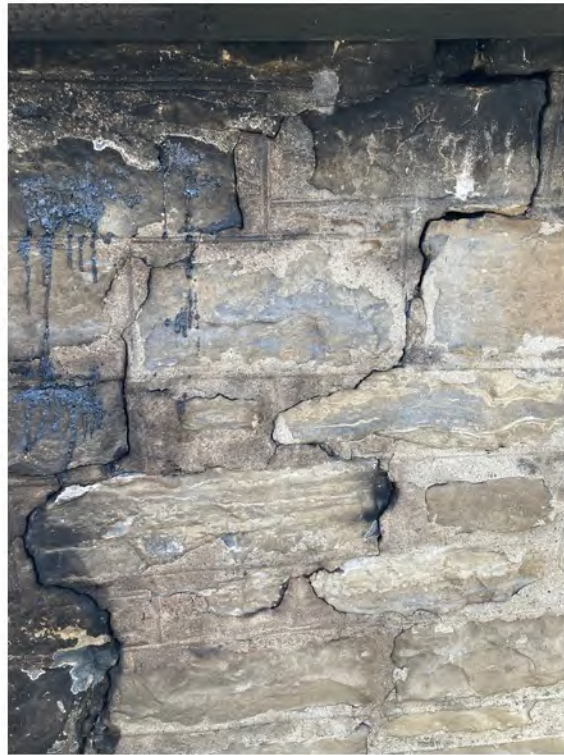
RE1 pyramidal crack

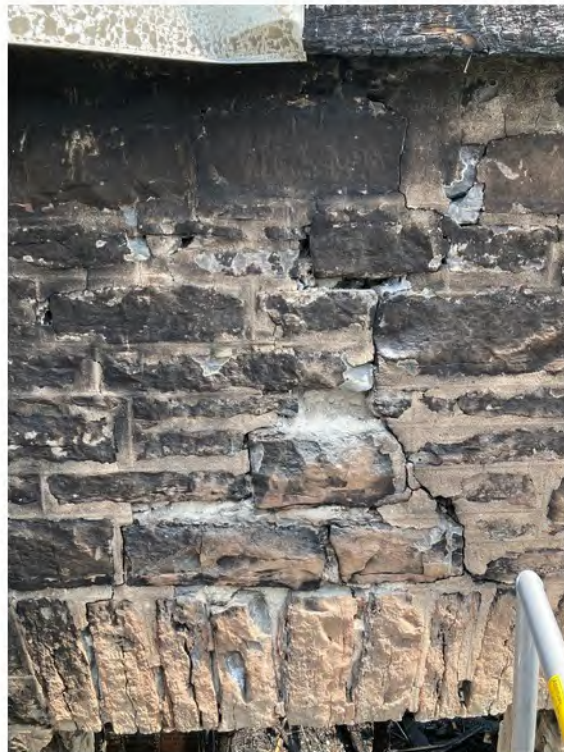
RE2 pyramidal crack

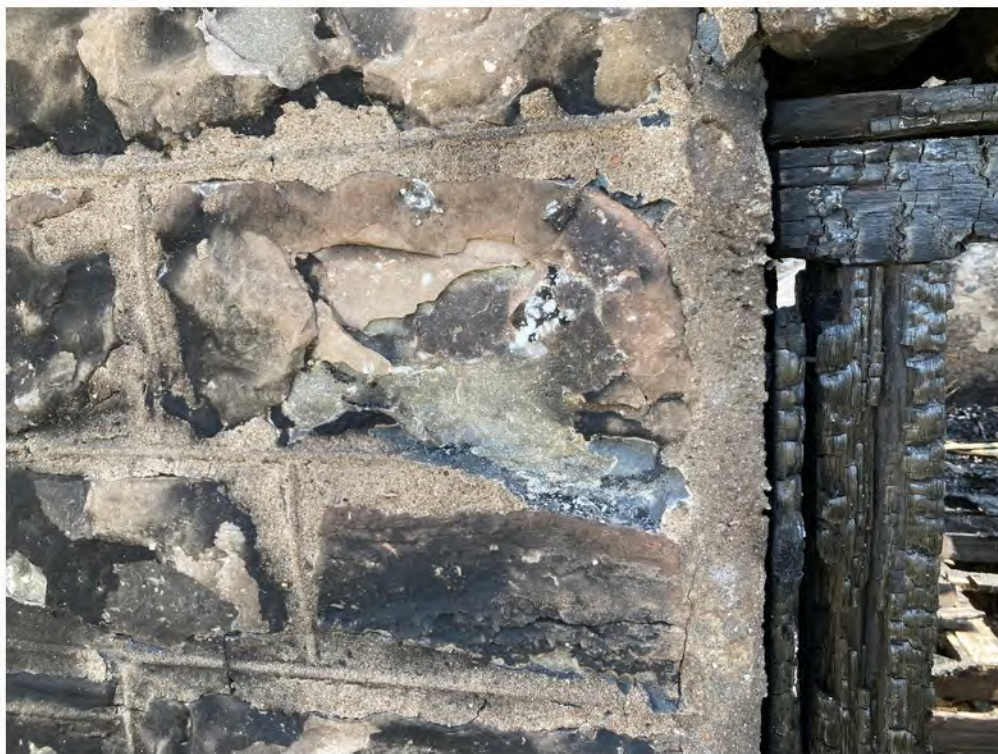
3A1 spalled out-of-bed sandstone Sample locn

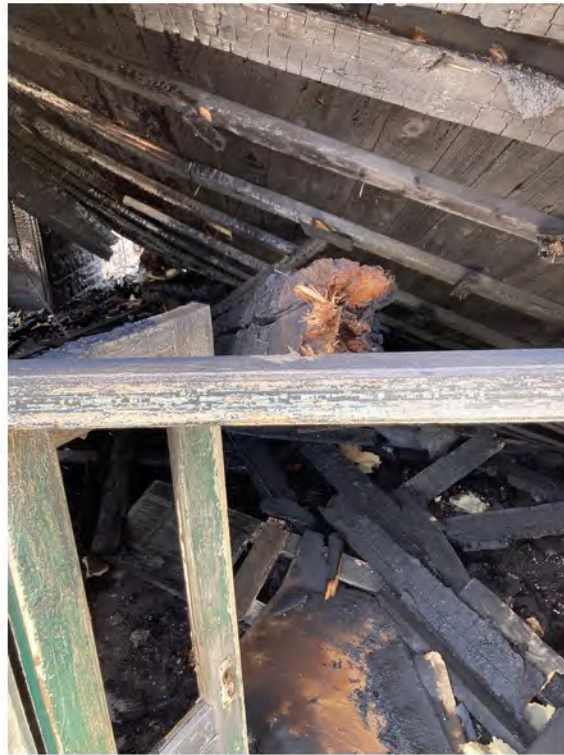
3E6.5 window frame supporting failed roof beam

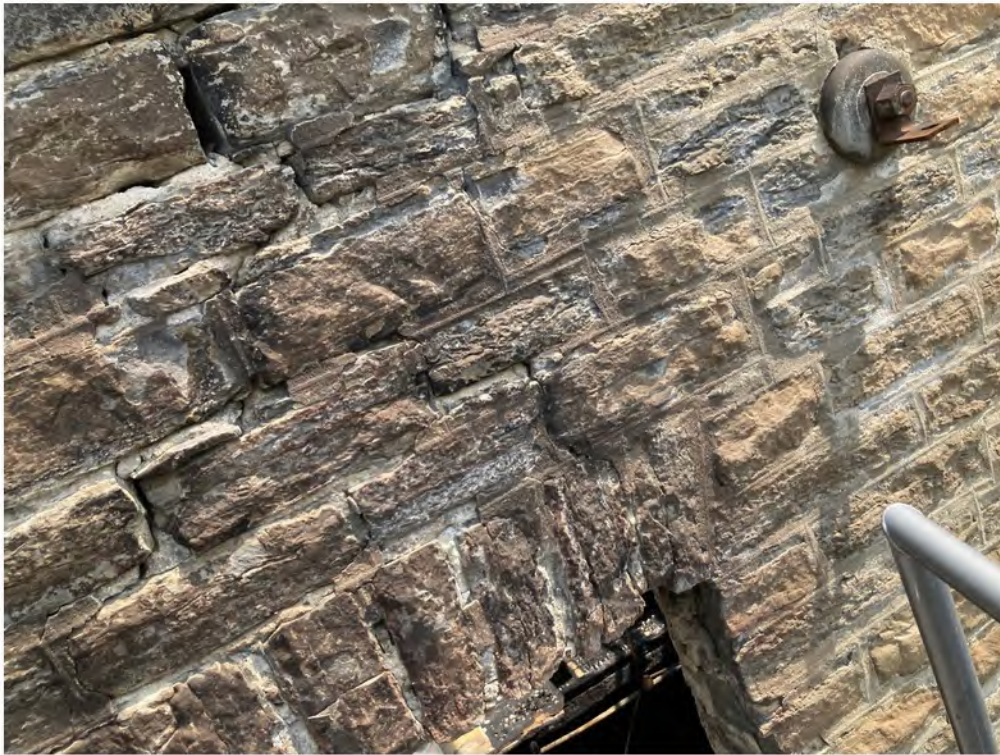
2E2 pyramidal cracking

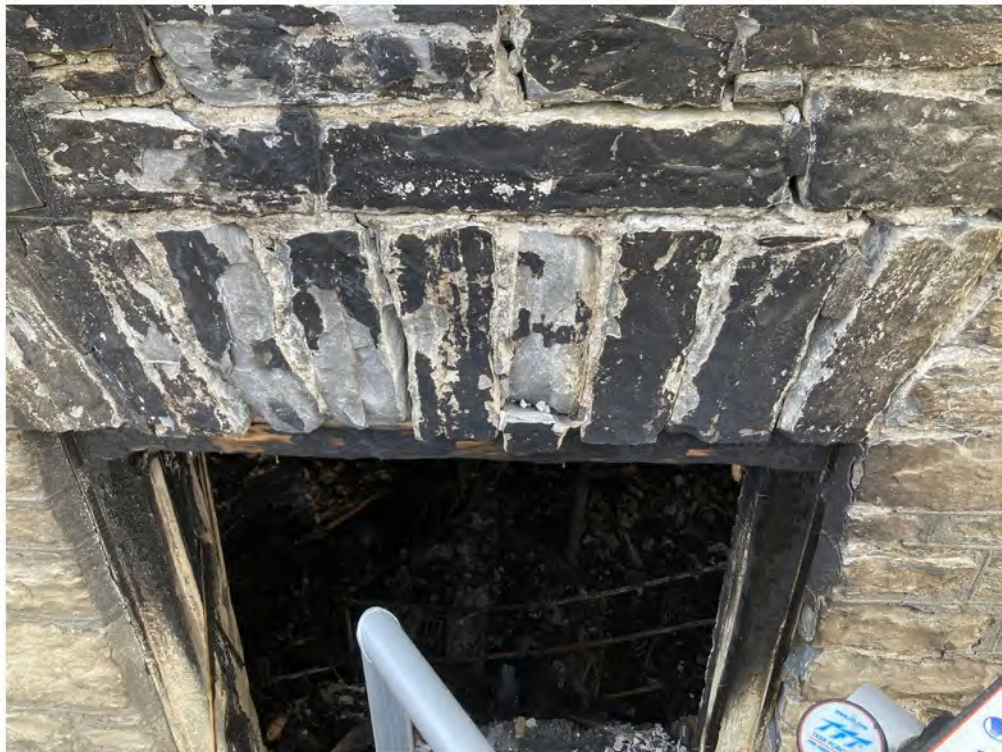
MB1 window voussoir Spalled lintel stone sample locn
