SMITHS FALLS
RISE AT THE FALLS

G. Douglas Vallee Limited

Heritage Building Structural Pathology Engineering Report

25 Old Mill Road
Town of Smiths Falls

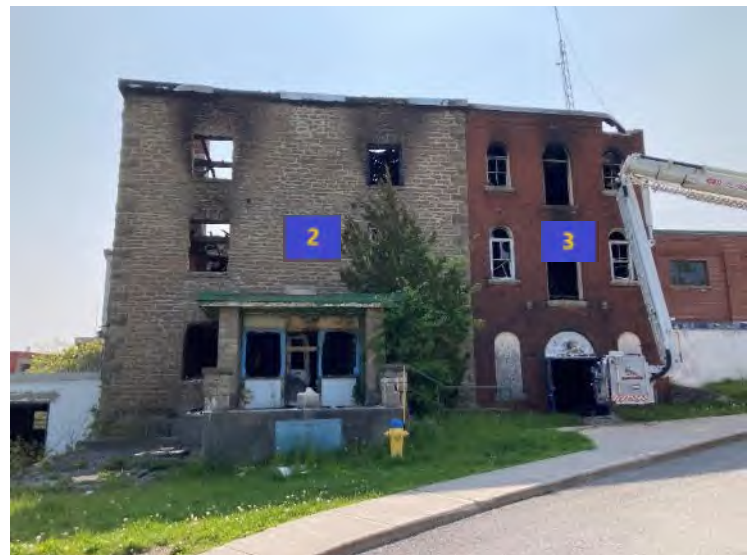
Fig 4. The west façade as seen on May 23, 2023.

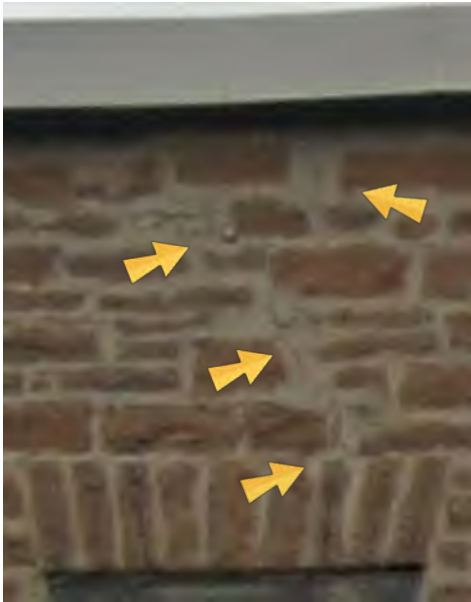
The photo comparison below is a crack located above the north window on the front face of the building at the roof level: gridpoint location 3E2 to RE2.

Fig 9a. Crack at 3E2-RE2 before...

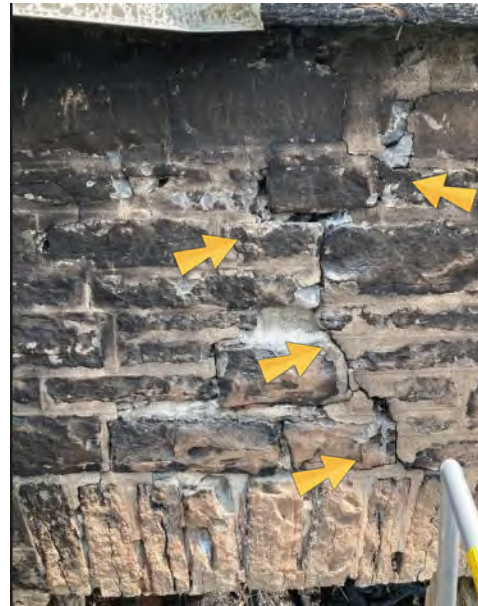
Fig 9b. ... and after.

This is an example of a pre-existing crack that had been repointed in a previous repair but remains in similar condition post-fire. Our general observations of the mortar indicate that the previous mortar repairs suffered the most damage as the previous bond to the original stone and mortar was likely compromised in areas such as this prior to the fire; thermal shock accelerated spalling of poorly bonded surficial repointed mortar.

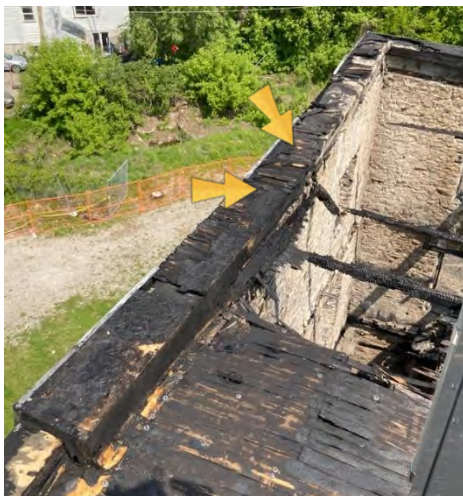
Fig. 10 Concave parapet at RE3.

Slight parapet concave and convex undulations noted at RE3 & RB1 in Figs. 10 & 11 appeared to be original to the building construction and not a result of the fire.

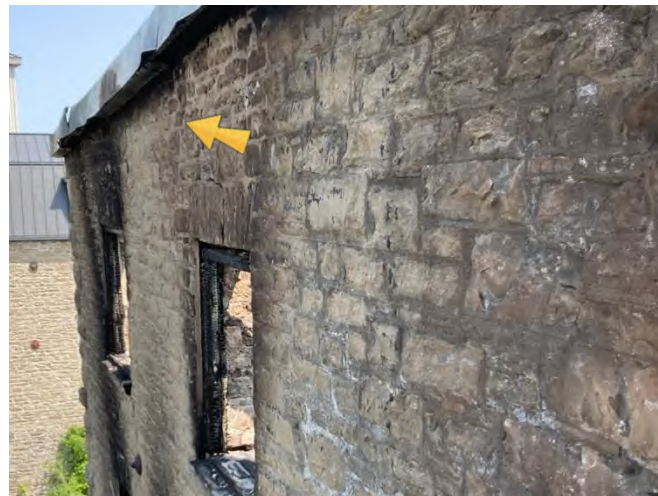
Fig.11 Convex parapet at RB1.

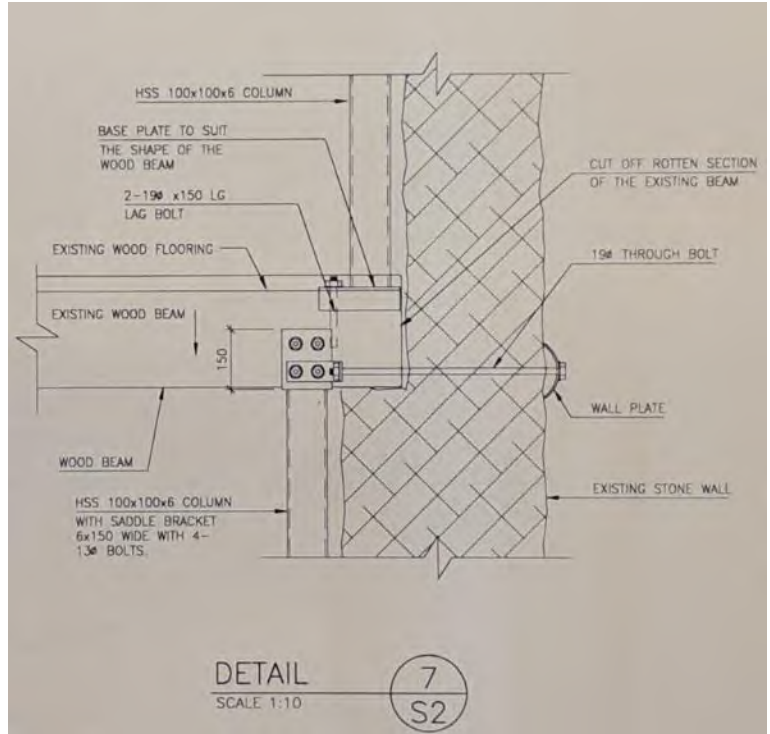
Fig 16. Typical stone wall anchor detail from 1994 work.

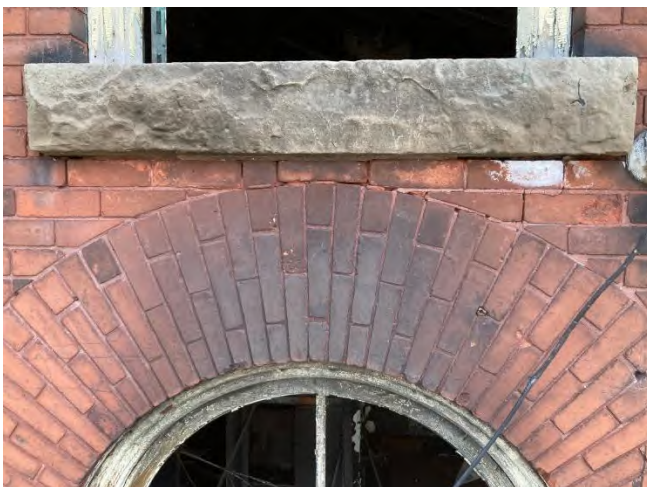
Fig 17. Brick voussoir and sill at 3E6.5.

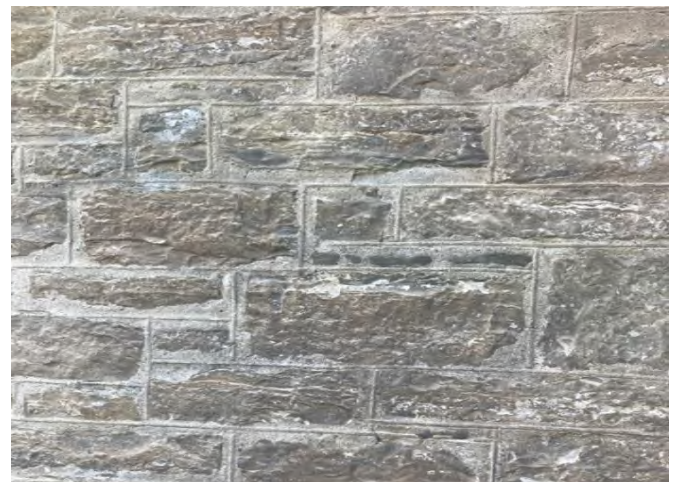
Areas that experienced high thermal gradients typically exhibit spalled repointed mortar. Areas of wall face that were not severely exposed to flame heat and thermal shock appear to remain in sound condition. This is evident in a large portion of the exterior wall faces that include stone and brick masonry in both buildings.

Fig 18. Typical stone face in good condition.

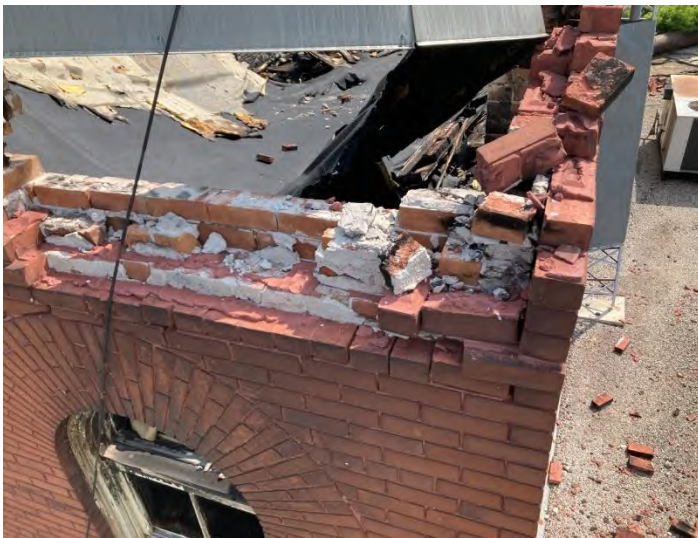
The damaged parapet at the southwest corner of Building 3 (1886 brick masonry) provided an opportunity to review the nature of the triple wythe masonry work as well as the condition and quality of the exterior and interior bricks. Iron (red) pigmented exterior mortar was observed in contrast to the interior mortar. The accumulated effects of over a century of freeze-thaw deterioration for exposed parapets weaken the mortar bond. The damage observed at RE8 and along the rear wall from RA5-RA8 would not be unexpected given the force applied by water pressure during firefighting. The physical characteristics of the mortars will be discussed in more detail in *Sub-Section 5.2 Material Analysis* and in the reference material analysis report from EDIFICE in the appendices.

Fig 19. Building 3 is triple wythe brick masonry.

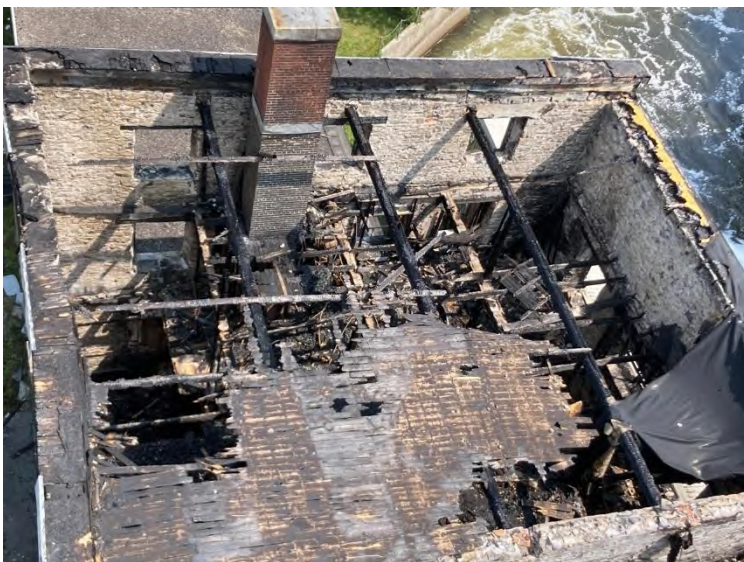
Fig 21. Aerial view of Building 2 interior.

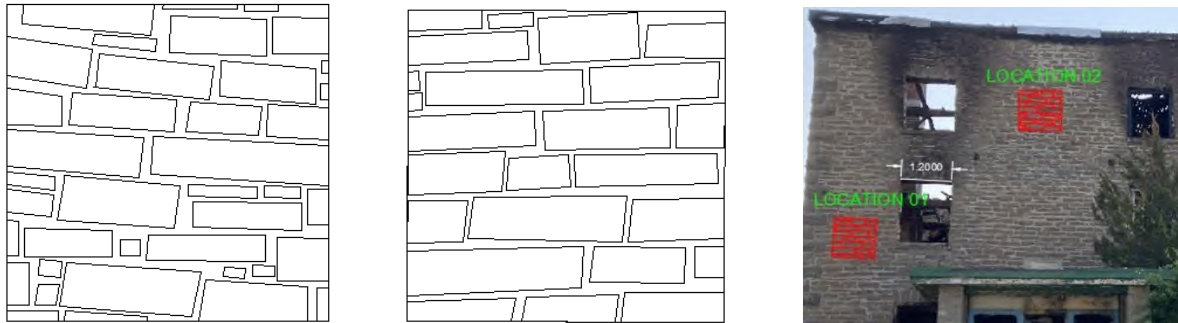
The density of the stone masonry wall was estimated using typical individual densities for sandstone and lime-based mortar and approximate proportions of sandstone to mortar (Figs. 21 & 22). This method was used at a number of locations throughout the building exterior and interior. This was done to determine an average composite density for the walls to be used in calculations of wall mass. This value was then compared to EDIFICE reported results and researched typical material densities. The proportions of sandstone to mortar were approximated by reviewing 1m² sections of the walls throughout the structure (Fig. 22) and calculating the average composition percentage of sandstone and mortar (lime based). The average composition of the typical stone masonry was approximated to be **78% sandstone and 22% mortar**.

Fig 21. Example of typical stone masonry composition determination method.

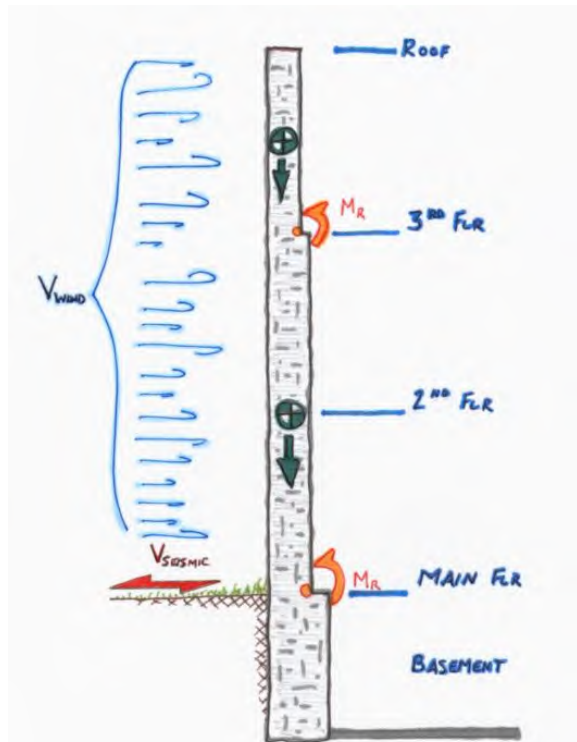
Fig 25. Schematic cross-section of wall.

The detailed drawings indicated the geometry of the area of greatest concern – Building 2, the original 1868 stone masonry mill. Of particular note, are the details of the wall construction geometry, which are dimensioned approximately 1.0m (3'3") thick for the perimeter of the foundation, 0.6m (2') thick for the main and second levels, and 0.5m (1'8") thick for the third level and roof parapet. These wall geometry characteristics were confirmed in the field as well as in the photographs appended.

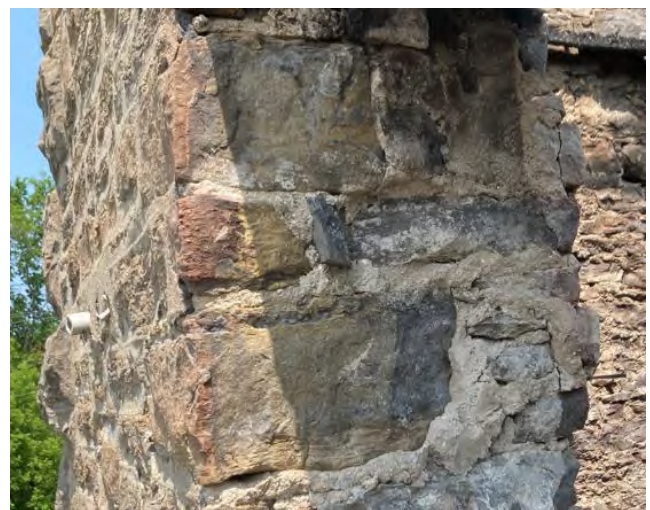
The cross section of the stone masonry was visible at openings, where wall thickness and interlocking stones between the interior and exterior faces can be observed.

Fig 26. Cross-section of wall at 2E2 opening.

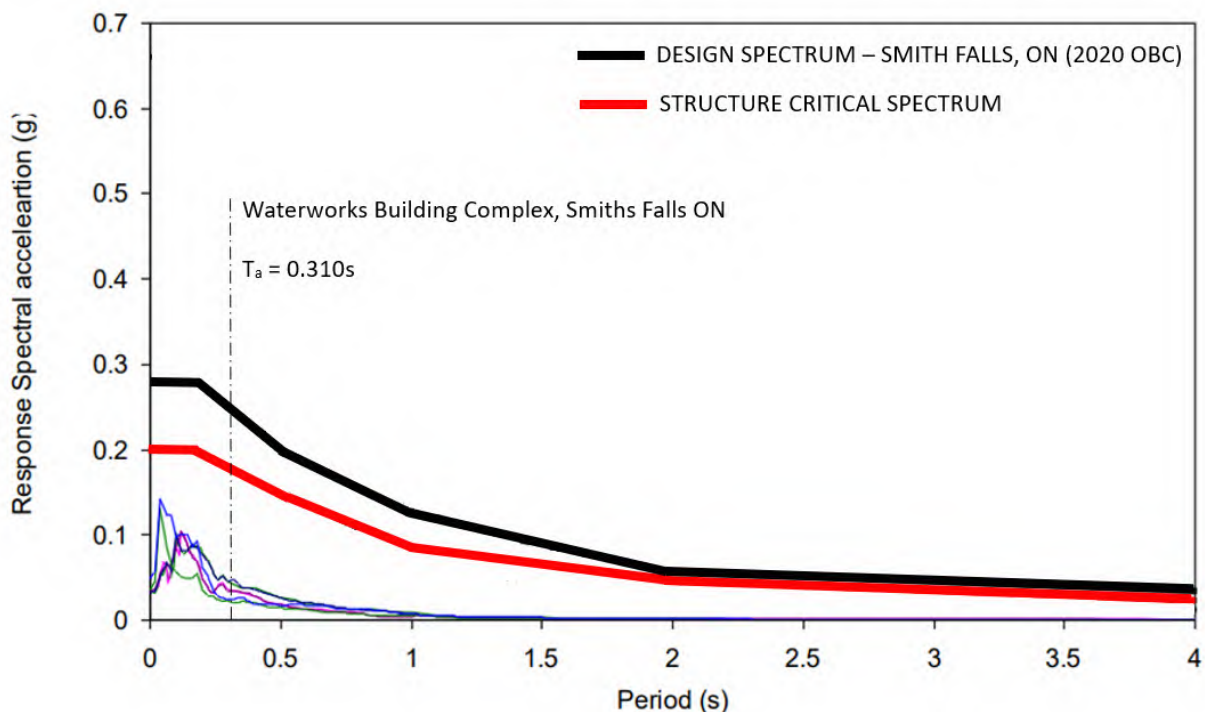
The equivalent seismic lateral load that could cause potential failure of the building was calculated based on the calculated resistance of the stone masonry wall. This is illustrated as the “*Structure Critical Spectrum*” (Refer to the red line on Fig. 29). Seismic events above the red line would likely cause failure. For comparison, the OBC design requirement (black line on Fig 29) and the seismic activity recorded during the Val-des-Bois earthquake (Refer to the colour data lines on Fig. 29) that occurred on June 23, 2010, are shown together on Fig 29. The recent (2010) Val-des-Bois event produced the strongest ground shaking felt in Ottawa since records were started in 1914.

When the response spectra from Val-des-Bois is compared to the “*Structure Critical Spectrum*” and the *Design Spectrum (OBC)* shown in Fig. 29 at the natural period of the structure ($T_a = 0.310\text{sec.}$), the forces experienced during Val-des-Bois were lower by a factor of approximately 3.9 and 5.4, respectively.

Fig 29. Val-des-Bois Response Spectra v. Design & Critical Spectra.

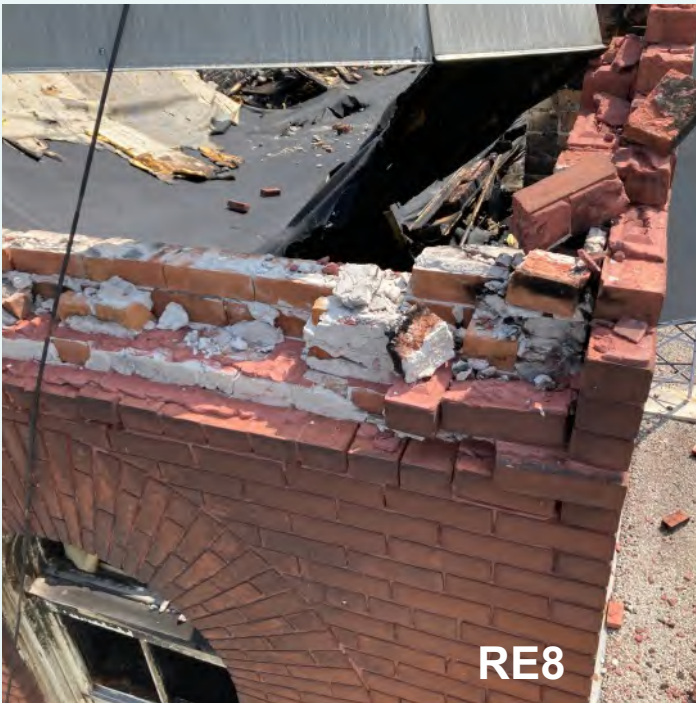
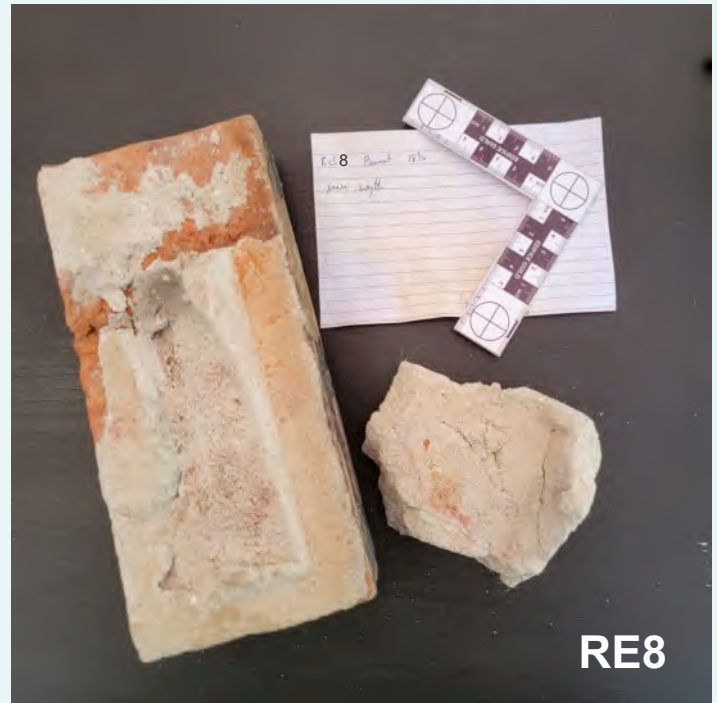
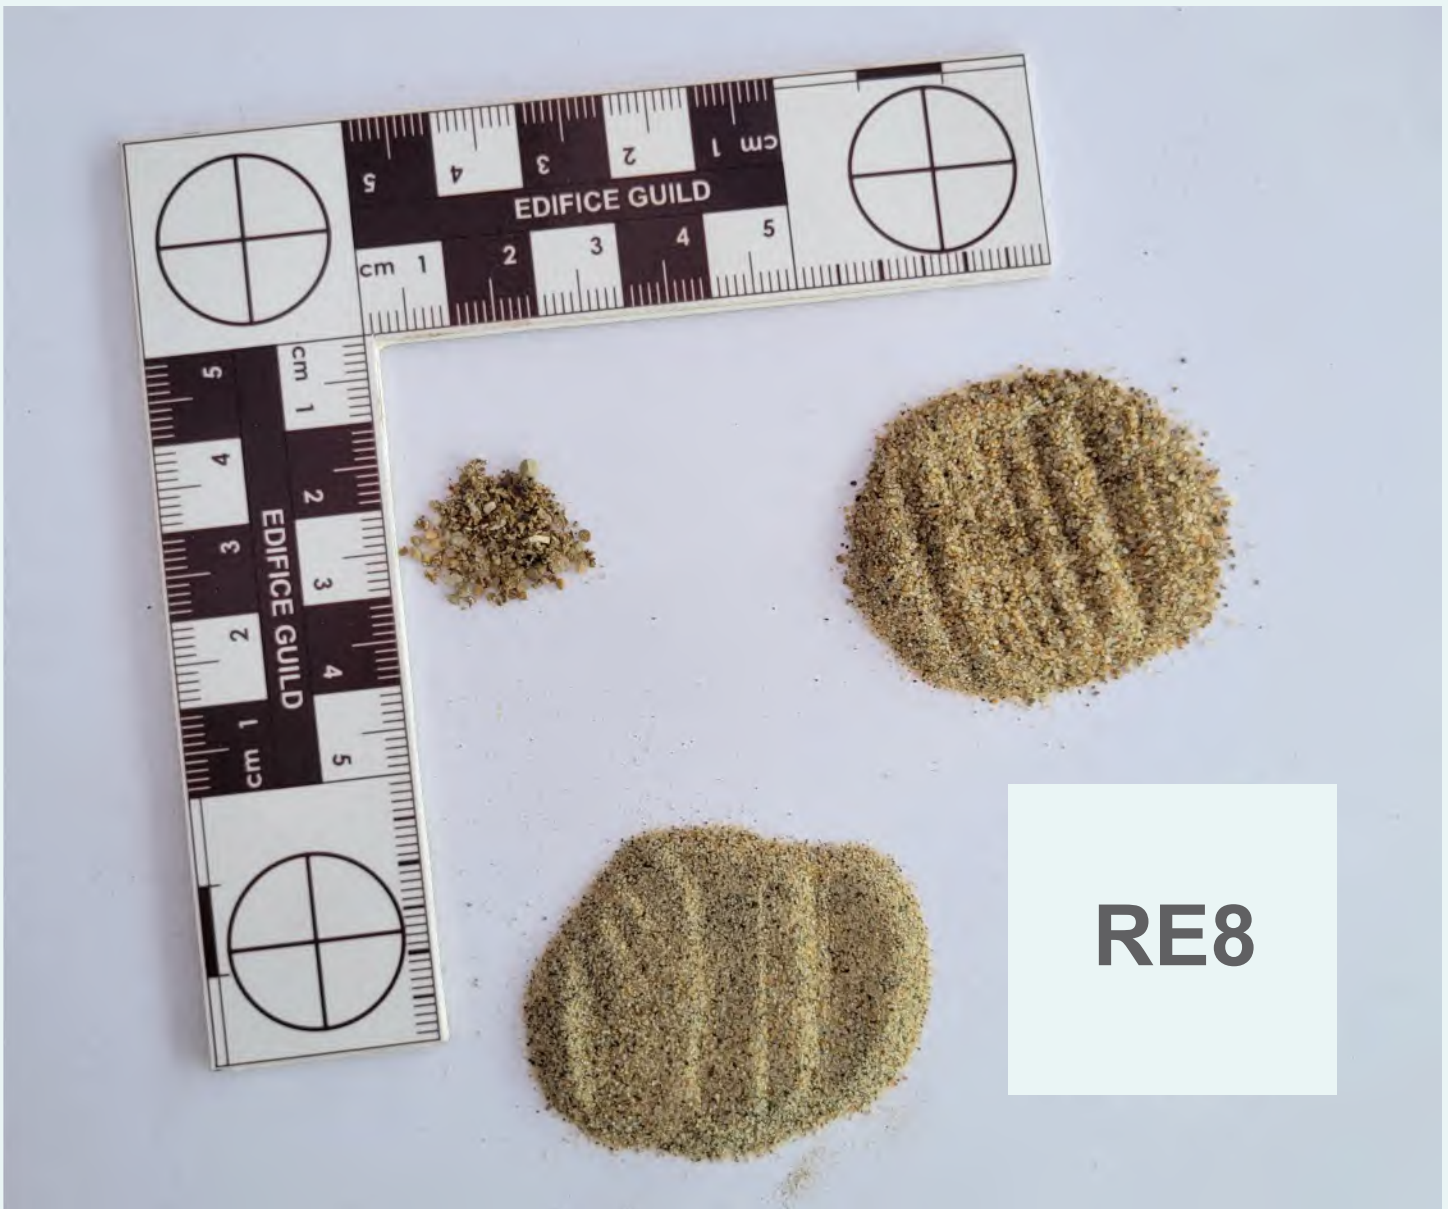
RE8 Inner Sample: Before WADT = 11.3g After WADT = 8.7g

The mix ratio of the sample is approximately 23.01% moderately hydraulic quicklime to 76.99% aggregate (by weight). Approximately 1 Part Lime to 3 Parts Aggregate by Weight.

The fines experienced a moderate water absorption rate, while fully intact sub-samples of mortar experienced moderate water absorption rates when subjected to the water droplet test. This fast water absorption rate within the intact sub-samples indicates an interconnected internal pore network that permits the fast and efficient absorption and transportation of moisture through the thickness of the mortar.

This sand has been preserved from a sieve mesh 4mm to 0.075 mm, with the highest percentage of aggregate having been retrieved from sieve mesh size 0.75mm with 52.36% by weight. The mortar is very well graded. Once dried, the mortar was found to be 10YR 7/3 'very pale brown' to 10YR 6/6 'pale brownish Yellow' when assessed against the Munsell Soil Colour Charts. This appears to be the same vernacular aggregate as the 1868 portion – simply well graded and sieved prior to mixing.

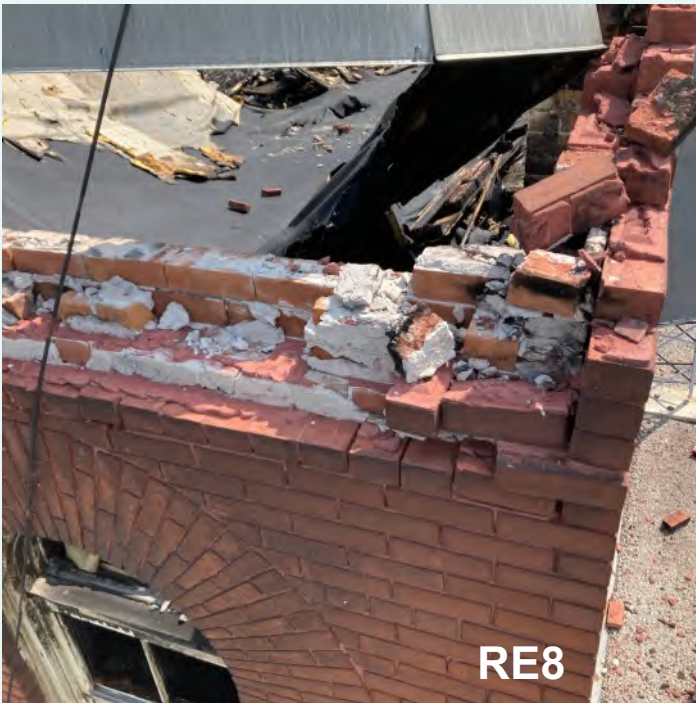
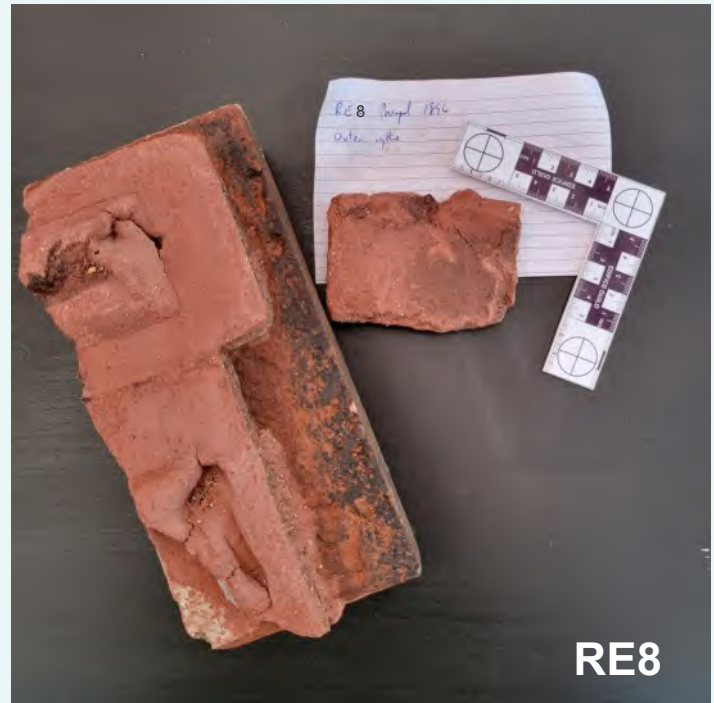
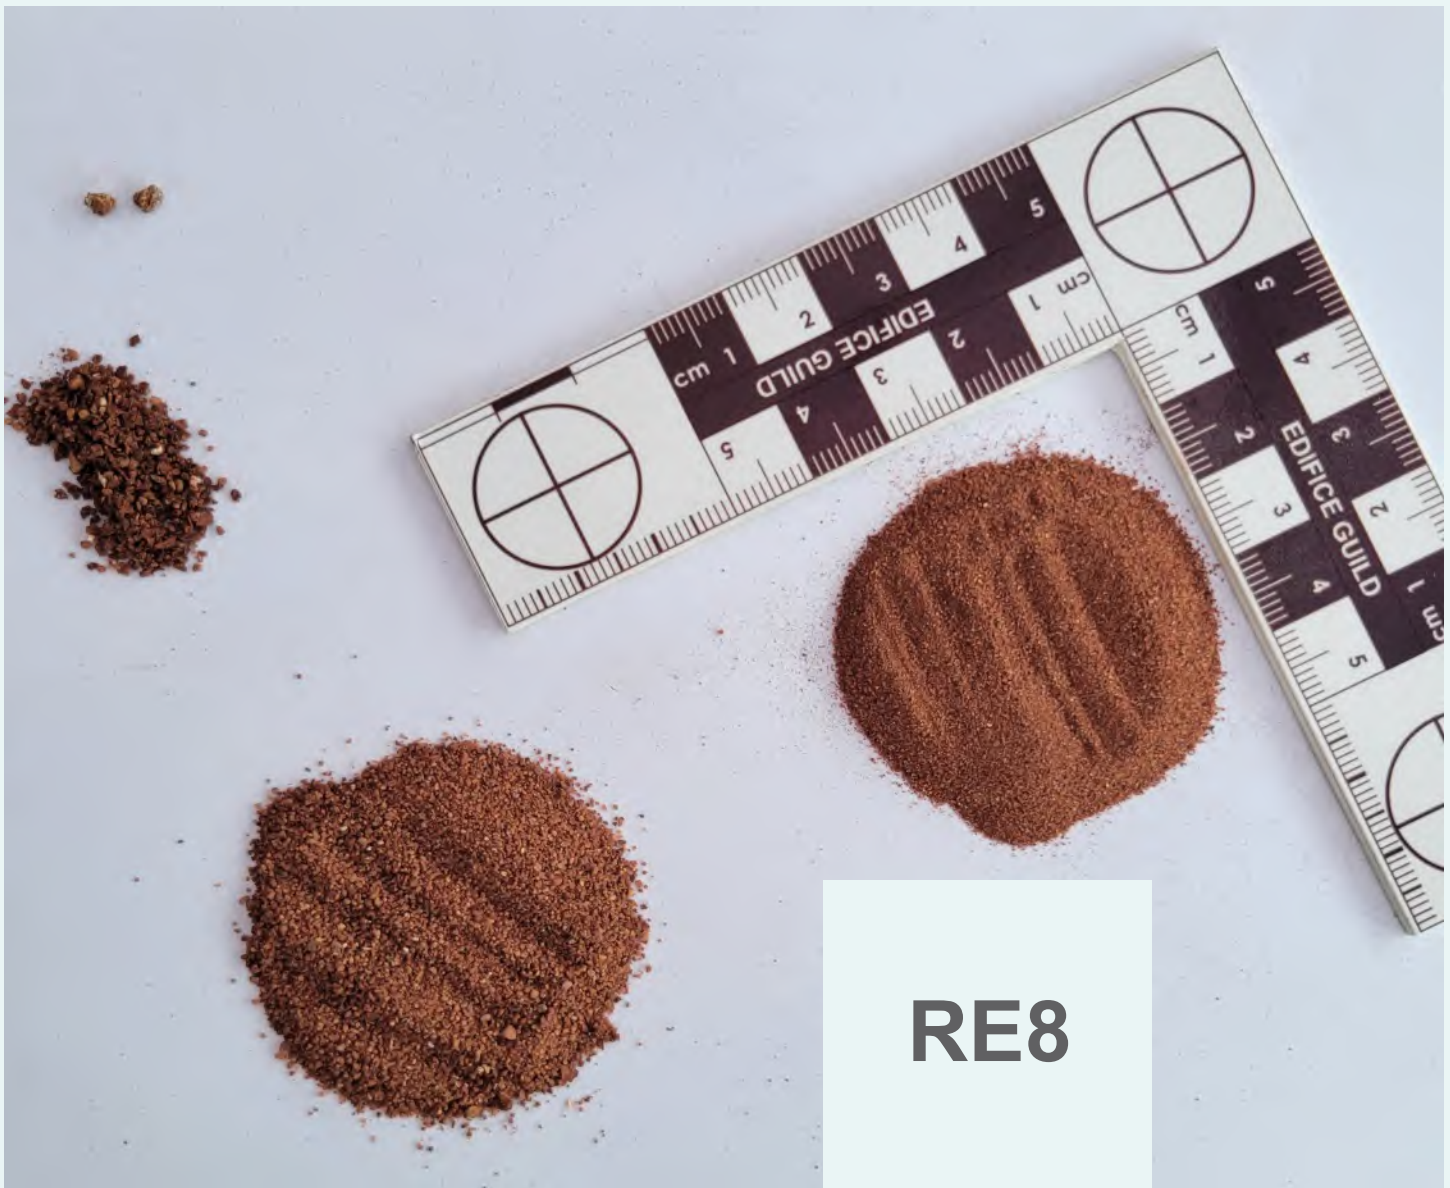
RE8 Ext. Sample Red: Before WADT = 14.7g Post WADT = 11.2g

The mix ratio of the sample is approximately 23.81% moderately hydraulic quicklime to 76.19% aggregate (by weight). Approximately 1 Part Lime to 3 Parts Aggregate by Weight

The fines experienced a moderate water absorption rate, while fully intact sub-samples of mortar experienced extremely fast water absorption rates when subjected to the water droplet test. This fast water absorption rate within the intact sub-samples indicates an interconnected internal pore network that permits the fast and efficient absorption and transportation of moisture through the thickness of the mortar.

This sand has been preserved from a sieve mesh 3mm to 0.075 mm, with the highest percentage of aggregate having been retrieved from sieve mesh size 0.75mm with 54.5%. The Munsell Soil Colour Charts could not be used on this sample due to the red iron oxide colouring of the mortar. This appears to be the same vernacular aggregate as the 1868 portion, simply well graded and sieved prior to mixing.

*Note: The Exterior Bricks sample (tinted red mortar) were very well bedded in mortar including the frogs (the indentation in the centre of the brick) filled. However, the interior brick wythes showed signs of less desirable bedding and partial frog filling.

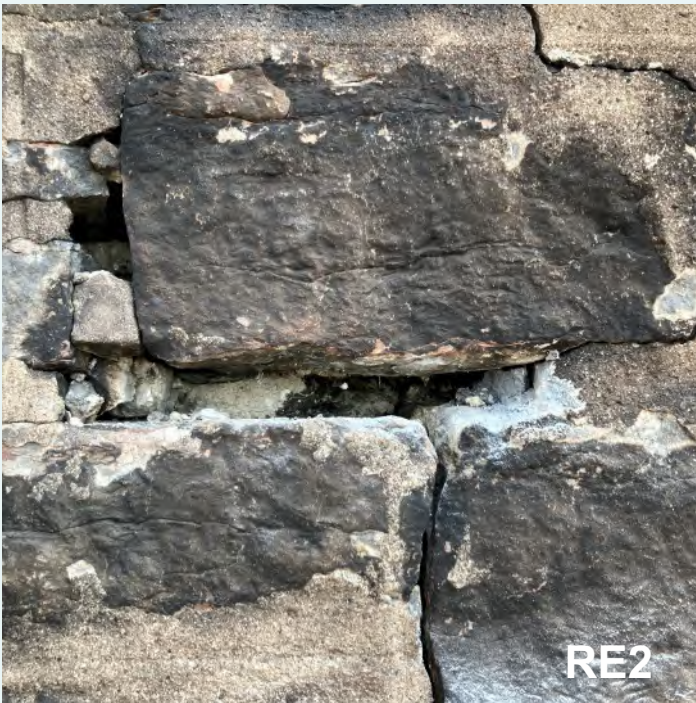
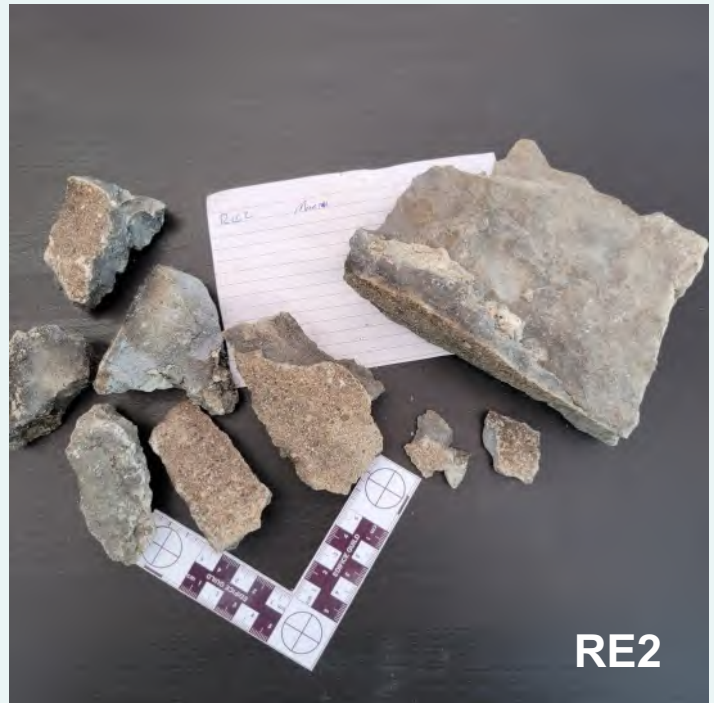
RE2 Sample Black: Before WADT = 9.7g Inconclusive Portland Cement

Black (pigmented) strap Portland cement repair pointing on the 1868 Goulds Mills building. These samples were tested to ascertain the composition of the mortar samples taken. They were found (an approximation through magnification) to be 1:1:2 (1 Lime, 1 Portland, 2 Sand). As this mortar does not make up any of the “Original” bedding or head mortar material and only used as a surficial repair solution in antiquity (c1930s) further testing is not required. Notwithstanding this, this type of mortar with a Portland Cement content should never be used on these buildings in any amount.

As this re-pointing is not an integral part of the make up of the two structures in question, and the Wet Acid Digestion Test obtained inconclusive results in exacting measurement of Portland Cement, Aggregate and Lime we can only provide a result of standard mixes during that time period and microscopic observation. Further testing with an electron microscope can be made, mapping and charting the grains of cement to aggregate. However, this mortar has no effect on the existing structures whatsoever, other than the possibility of a negative effect on spalling both stone and brick due to its (the mortar) inability to be permeable.

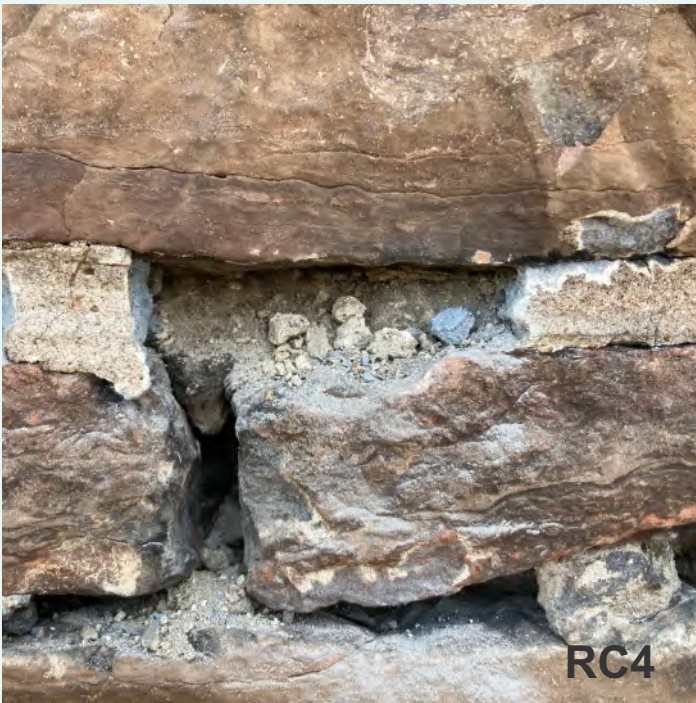
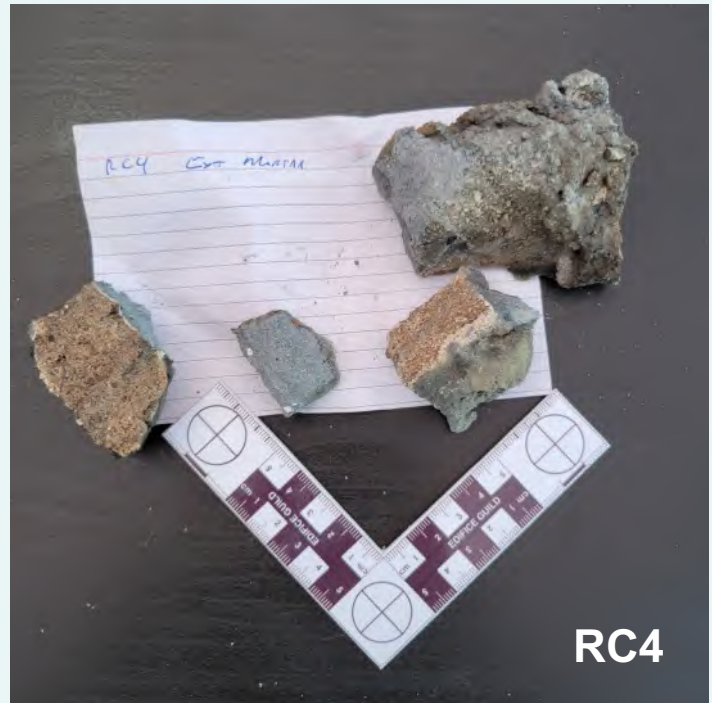
RC4 Sample Black: Before WADT = 13.1g Inconclusive Portland Cement

Black (pigmented) strap Portland cement repair pointing on the 1868 Goulds Mills building. These samples were tested to ascertain the composition of the mortar samples taken. They were found (an approximation through magnification) to be 1:1:2 (1 Lime, 1 Portland, 2 Sand). As this mortar does not make up any of the “Original” bedding or head mortar material and only used as a surficial repair solution in antiquity (c1930s) further testing is not required. Notwithstanding this, this type of mortar with a Portland Cement content should never be used on these buildings in any amount.

As this re-pointing is not an integral part of the make up of the two structures in question, and the Wet Acid Digestion Test obtained inconclusive results in exacting measurement of Portland Cement, Aggregate and Lime we can only provide a result of standard mixes during that time period and microscopic observation. Further testing with an electron microscope can be made, mapping and charting the grains of cement to aggregate. However, this mortar has no effect on the existing structures whatsoever, other than the possibility of a negative effect on spalling both stone and brick due to its (the mortar) inability to be permeable.

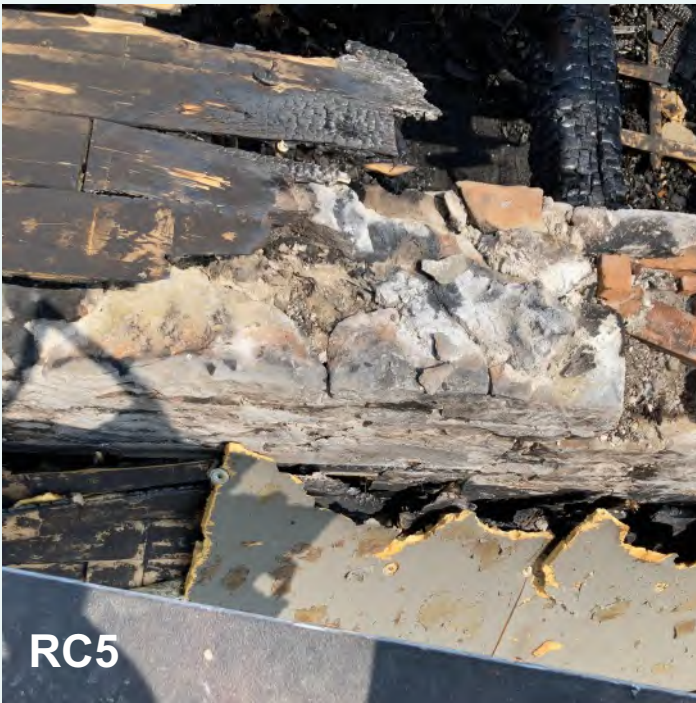
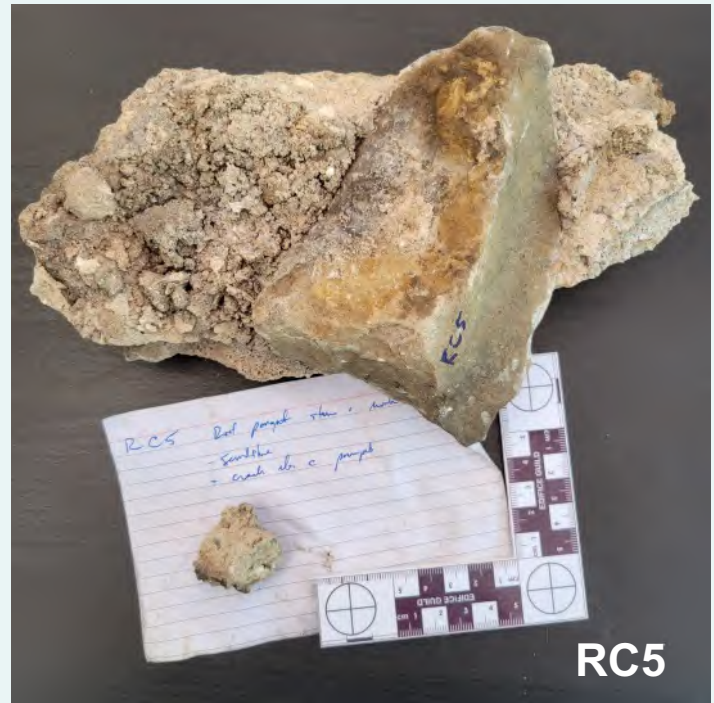
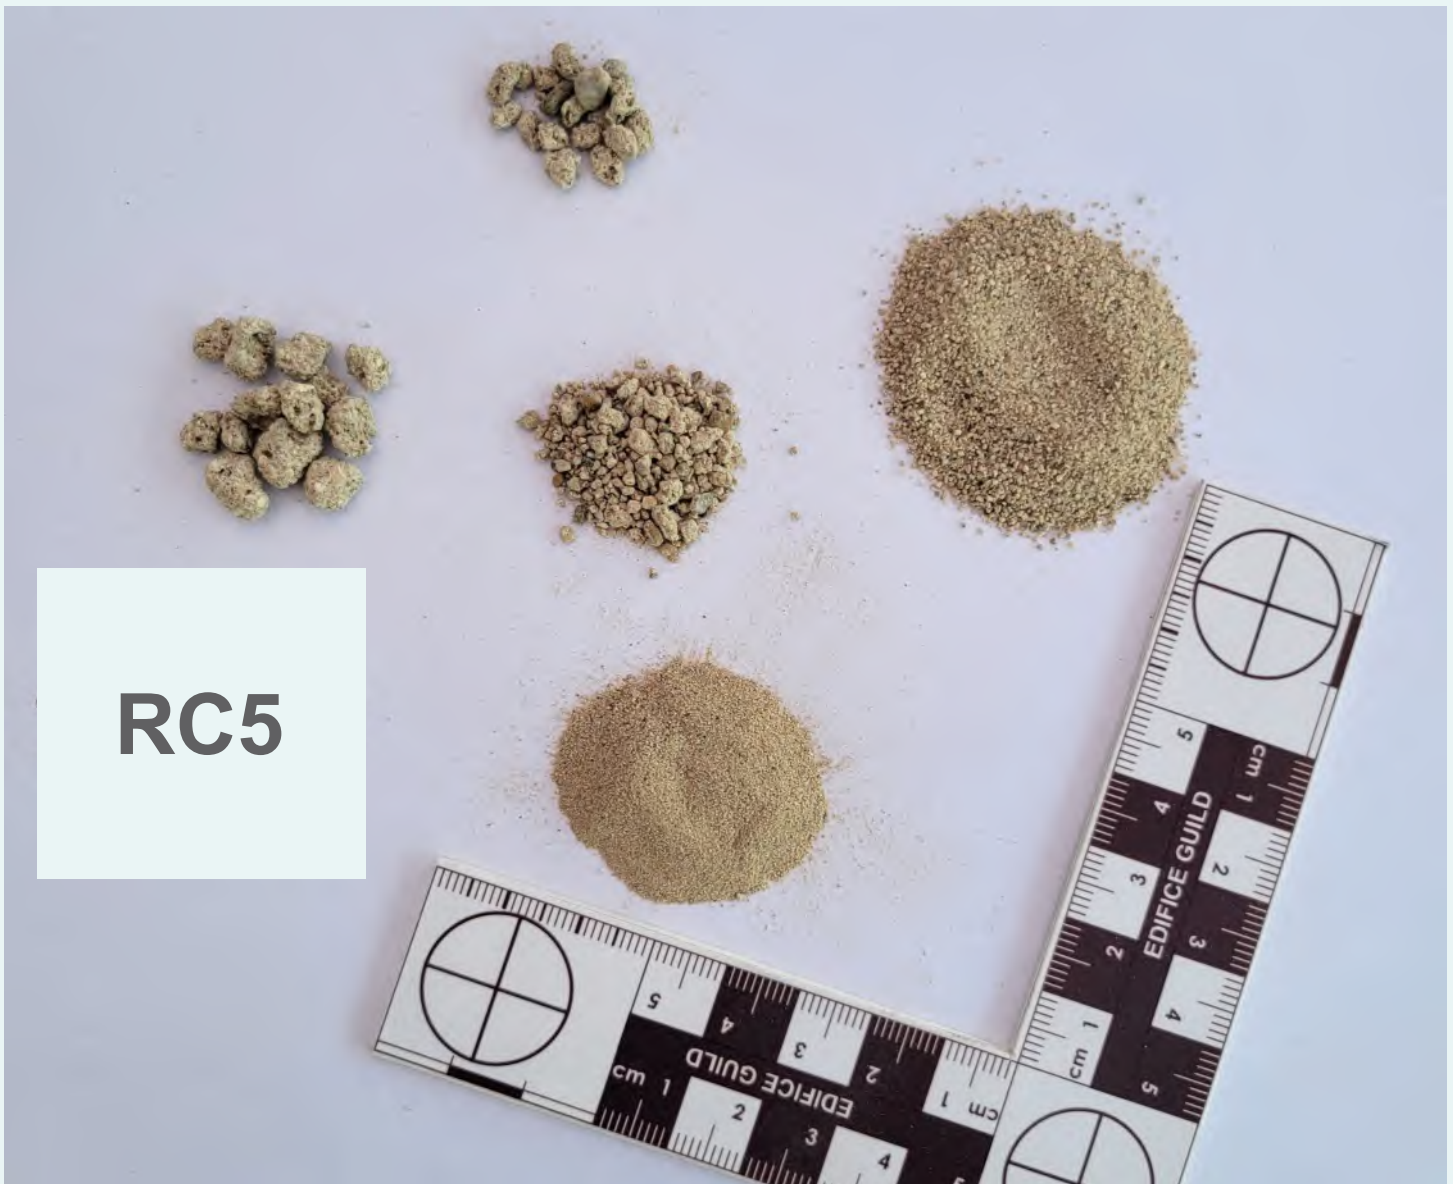
RC5 Sample: Before WADT = 15.6g Post WADT = 11.8g

The mix ratio of the sample is approximately 24.36% moderately hydraulic quicklime to 75.64% aggregate (by weight). Approximately 1 Part Lime to 3 Parts Aggregate by Weight.

The fines experienced a moderate water absorption rate, while fully intact sub-samples of mortar experienced fast water absorption rates when subjected to the water droplet test. This fast water absorption rate within the intact sub-samples indicates an interconnected internal pore network that permits the fast and efficient absorption and transportation of moisture through the thickness of the mortar.

This sand has been preserved from a sieve mesh 4mm to 0.075 mm, with the highest percentage of aggregate having been retrieved from sieve mesh size 0.75mm with 31.5% by weight. The mortar is very ungraded, Once dried, the mortar was found to be 10YR 7/3 'very pale brown' to 10YR 6/6 'pale brownish Yellow' when assessed against the Munsell Soil Colour Charts.

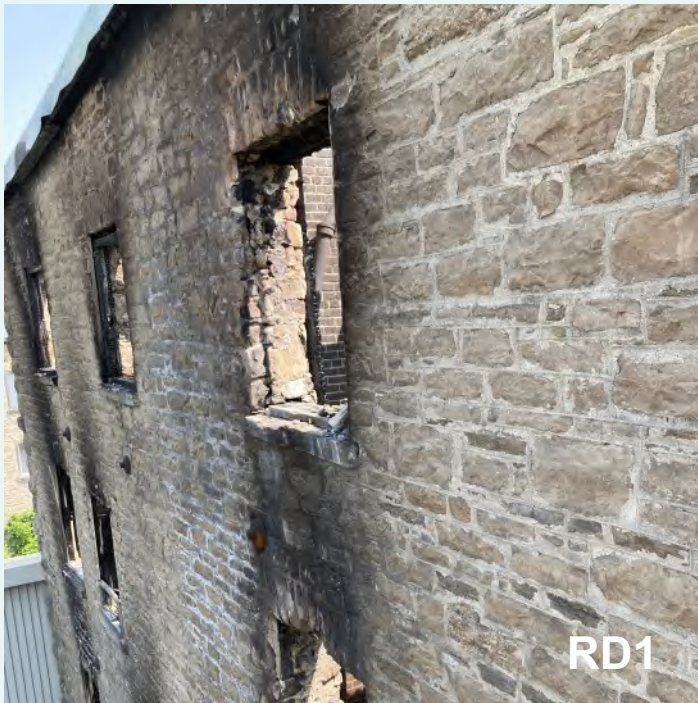
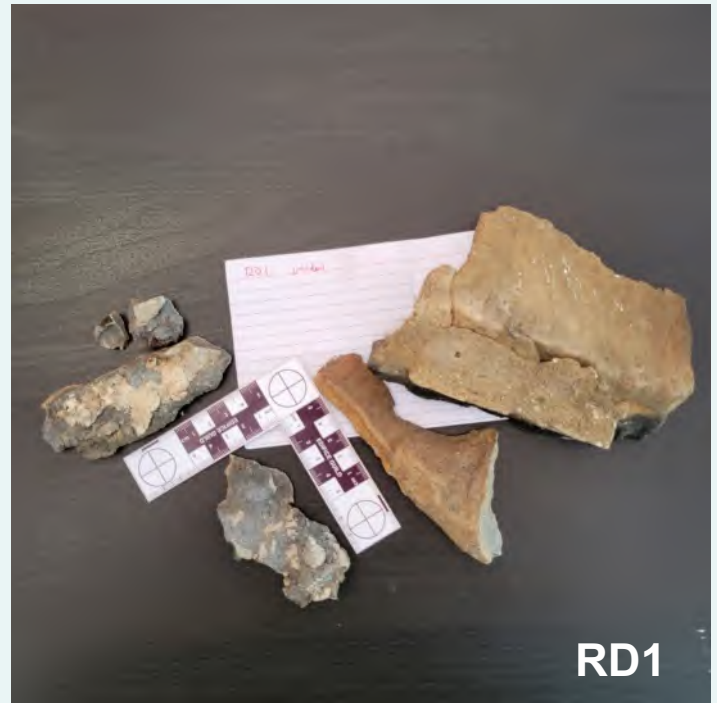
RD1 Sample Black: Before WADT = 12.5g Inconclusive Portland Cement

Black (pigmented) strap Portland cement repair pointing on the 1868 Goulds Mills building. These samples were tested to ascertain the composition of the mortar samples taken. They were found (an approximation through magnification) to be 1:1:2 (1 Lime, 1 Portland, 2 Sand). As this mortar does not make up any of the “Original” bedding or head mortar material and only used as a surficial repair solution in antiquity (c1930s) further testing is not required. Notwithstanding this, this type of mortar with a Portland Cement content should never be used on these buildings in any amount.

As this re-pointing is not an integral part of the make up of the two structures in question, and the Wet Acid Digestion Test obtained inconclusive results in exacting measurement of Portland Cement, Aggregate and Lime we can only provide a result of standard mixes during that time period and microscopic observation. Further testing with an electron microscope can be made, mapping and charting the grains of cement to aggregate. However, this mortar has no effect on the existing structures whatsoever, other than the possibility of a negative effect on spalling both stone and brick due to its (the mortar) inability to be permeable.
