SMITHS FALLS
RISE AT THE FALLS

G. Douglas Vallee Limited

Heritage Building Structural Pathology Engineering Report

25 Old Mill Road
Town of Smiths Falls

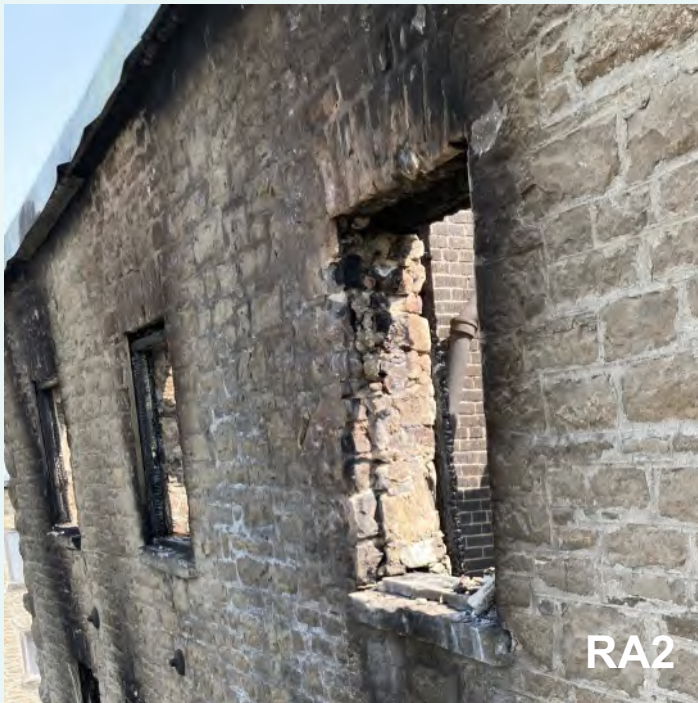
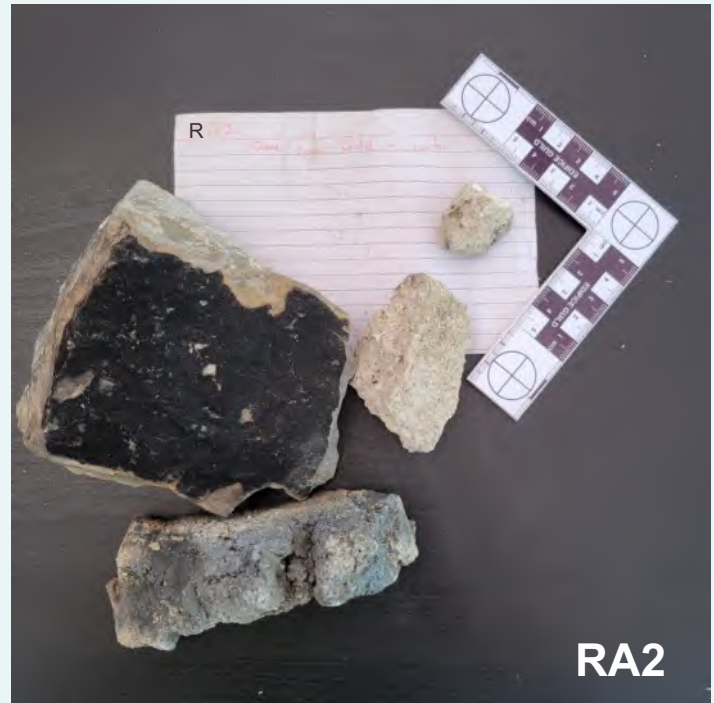
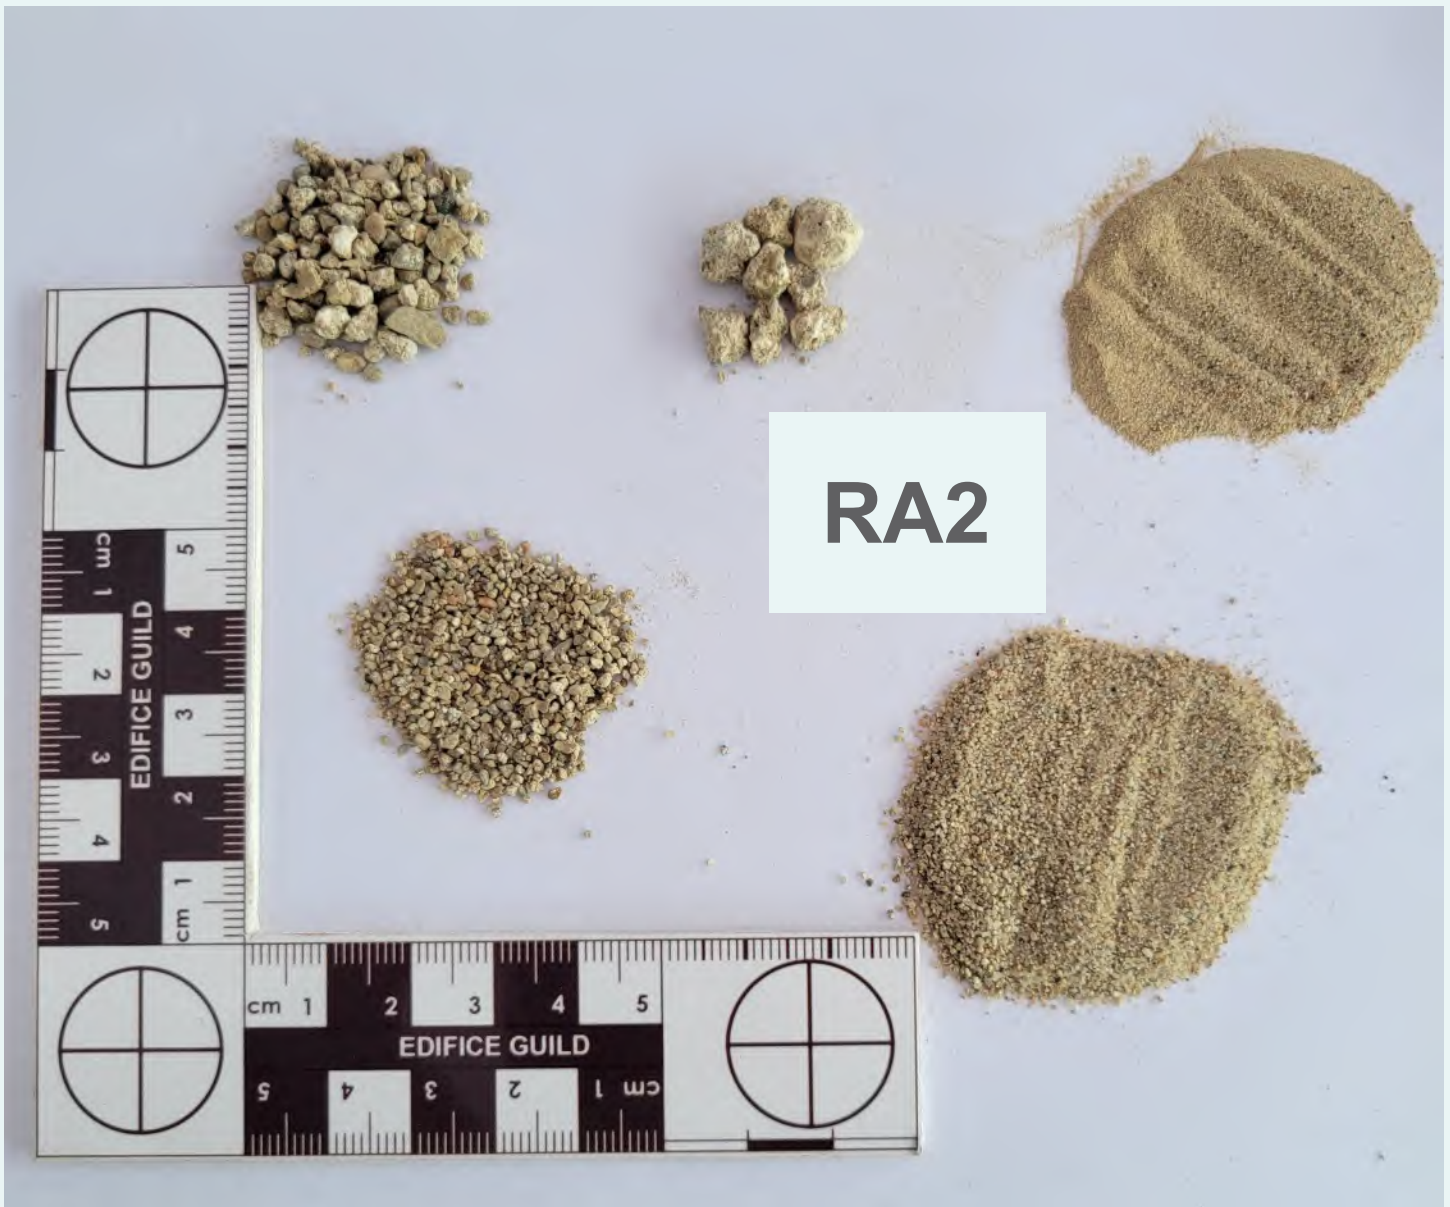
RA2 Sample: Before WADT = 16.4g Post WADT = 11.9g

The mix ratio of the sample is approximately 27.44 % moderately hydraulic quicklime to 72.56 % aggregate (by weight). Approximately 1 Part Lime to 3 Parts Aggregate by Weight.

The fines experienced a moderate water absorption rate, while fully intact sub-samples of mortar experienced fast water absorption rates when subjected to the water droplet test. This fast water absorption rate within the intact sub-samples indicates an interconnected internal pore network that permits the fast and efficient absorption and transportation of moisture through the thickness of the mortar.

This sand has been preserved from a sieve mesh 4mm to 0.075 mm, with the highest percentage of aggregate having been retrieved from sieve mesh size 0.75mm with 39.13% by weight. The mortar is very ungraded. Once dried, the mortar was found to be 10YR 7/3 'very pale brown' to 10YR 6/6 'pale brownish Yellow' when assessed against the Munsell Soil Colour Charts.

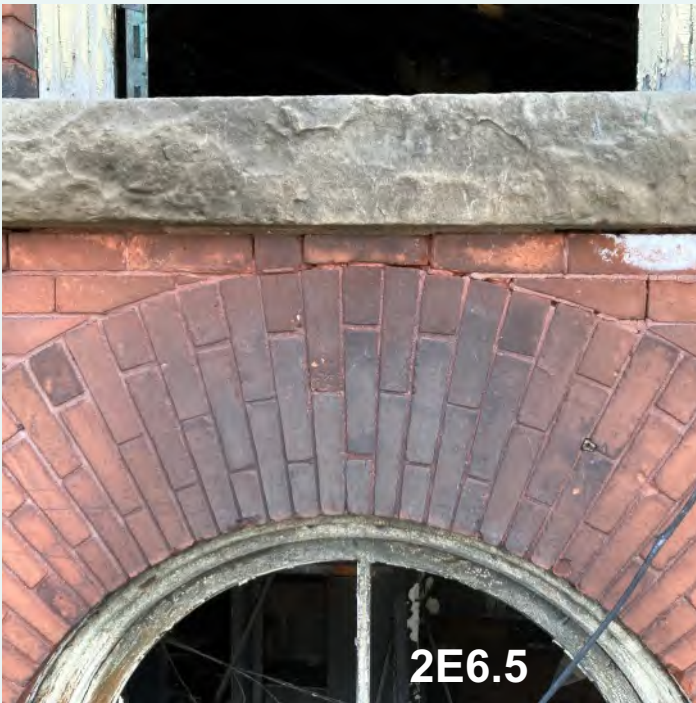
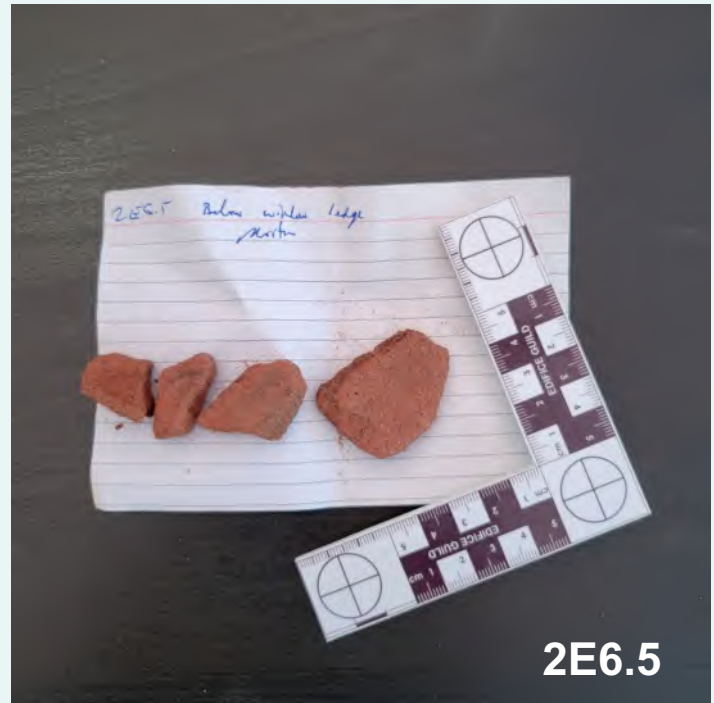
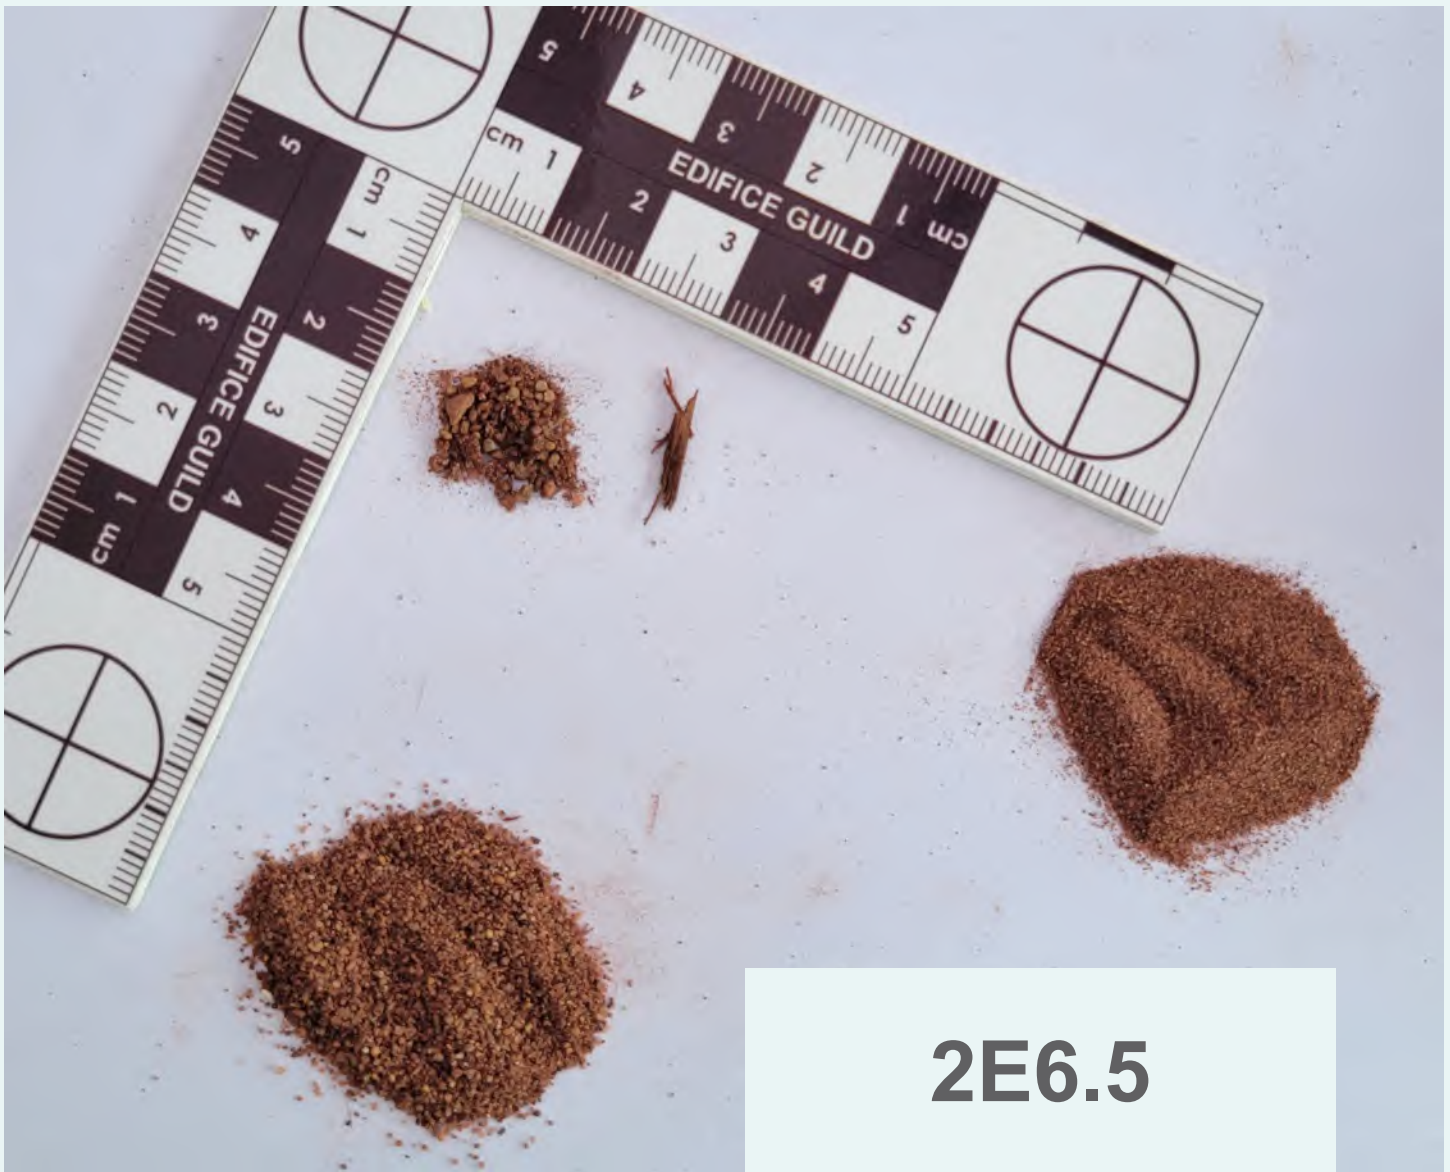
2E6.5 Sample: Before WADT = 7.5g Post WADT = 4.6g

The mix ratio of the sample is approximately 38.67 % moderately hydraulic quicklime to 61.33 % aggregate (by weight). Approximately 1 Part Lime to 2.5 Parts Aggregate by Weight.

The fines experienced a moderate water absorption rate, while fully intact sub-samples of mortar experienced extremely fast water absorption rates when subjected to the water droplet test. This fast water absorption rate within the intact sub-samples indicates an interconnected internal pore network that permits the fast and efficient absorption and transportation of moisture through the thickness of the mortar.

This sand has been preserved from a sieve mesh 4mm to 0.075 mm, with the highest percentage of aggregate having been retrieved from sieve mesh size 0.75mm with 53.2% by weight. The Munsell Soil Colour Charts could not be used on this sample due to the red iron oxide colouring of the mortar. This appears to be the same vernacular aggregate as the 1868 portion, simply well graded and sieved prior to mixing.

*Note: The Exterior Bricks sample (tinted red mortar) were very well bedded in mortar including the frogs (the indentation in the centre of the brick) filled. However, the interior brick wythes showed signs of less desirable bedding and

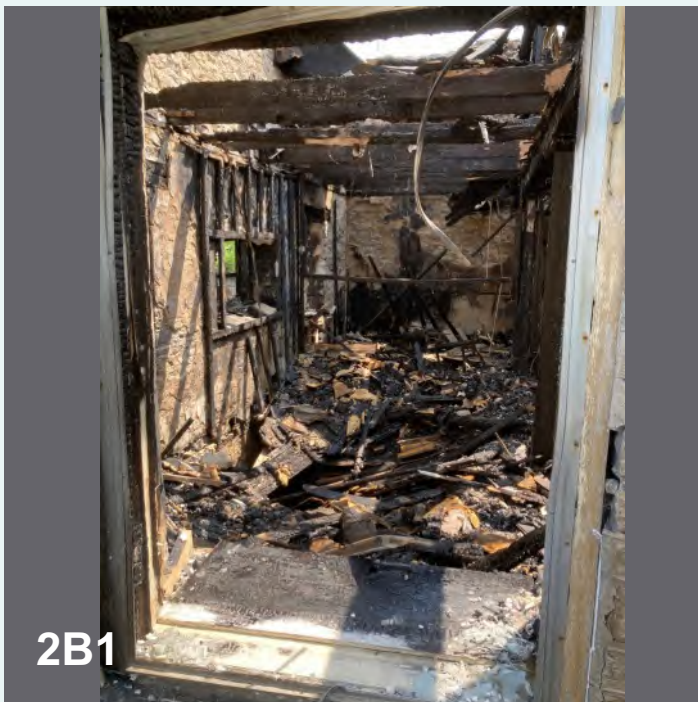
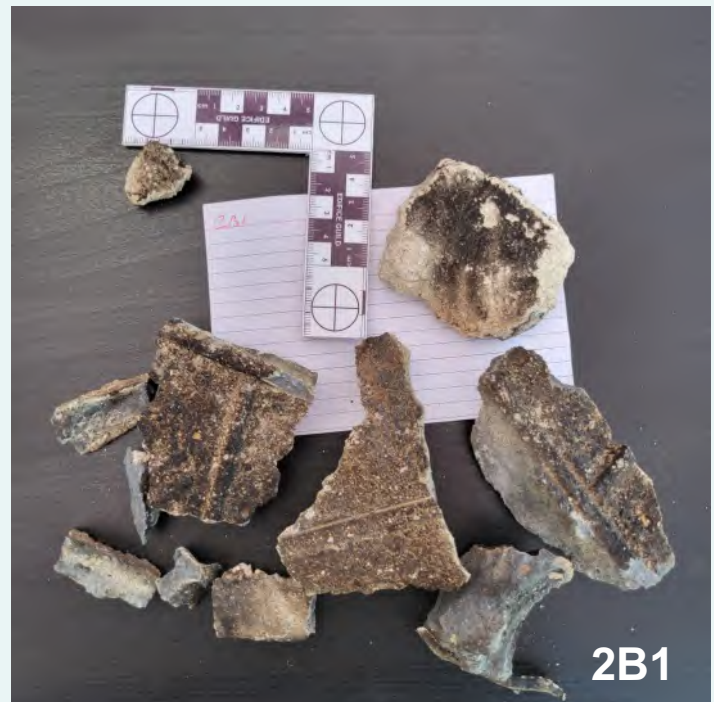
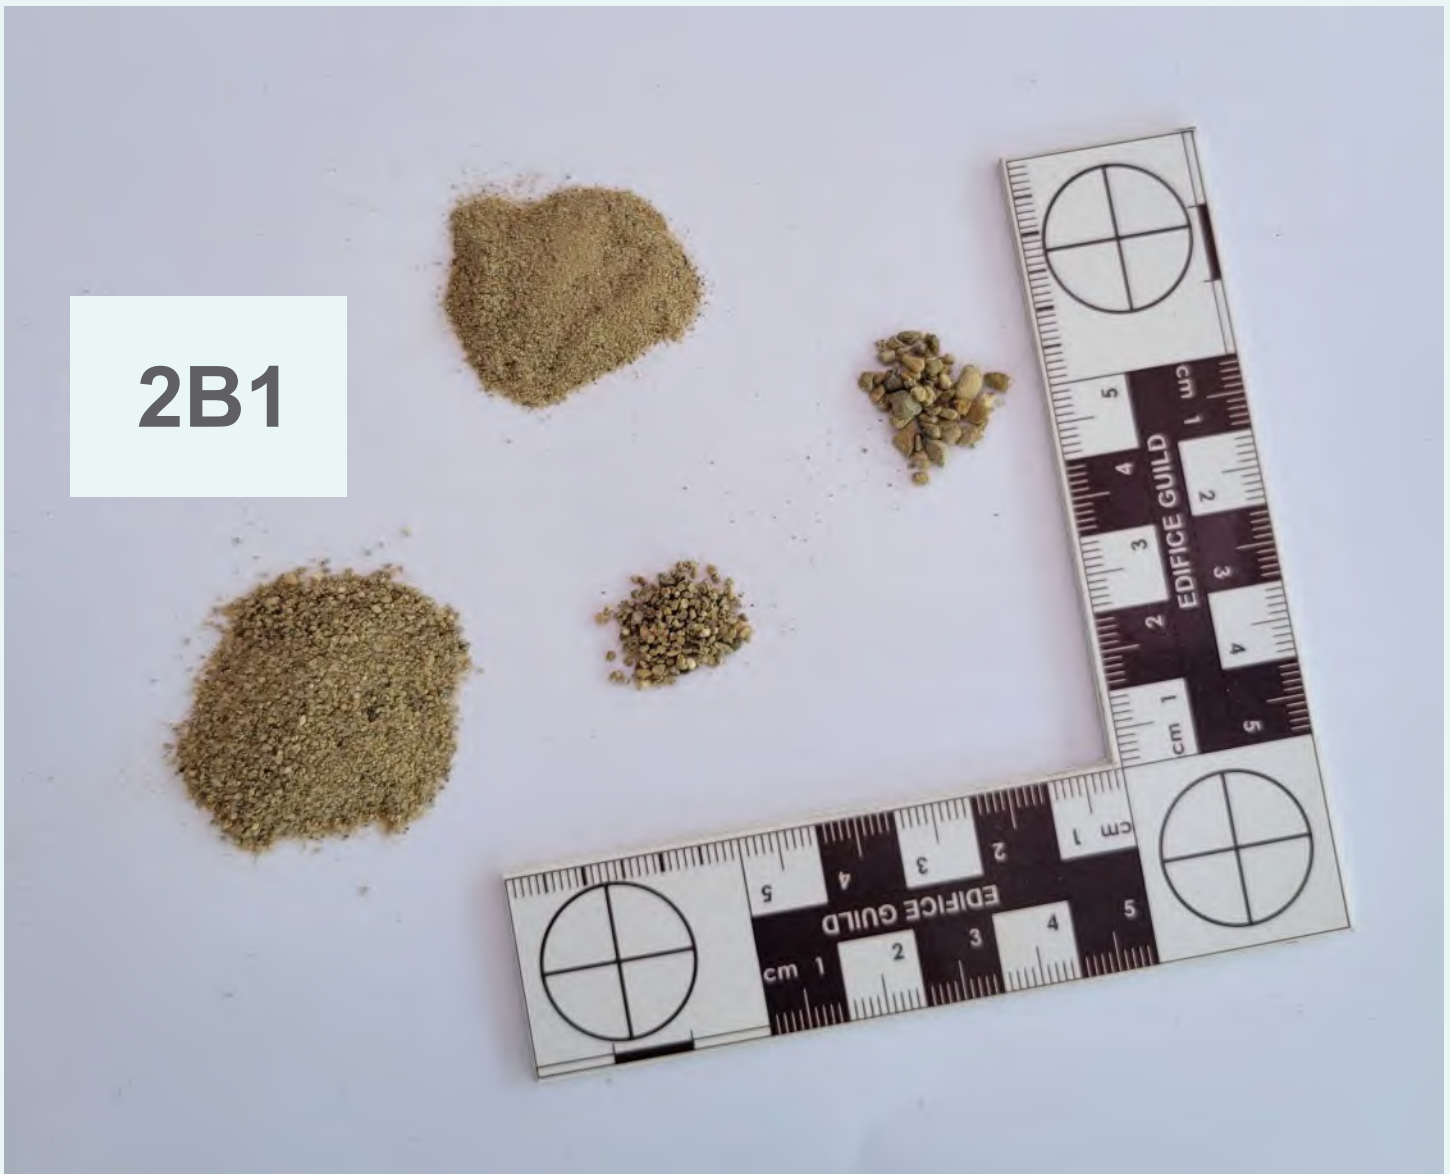
2B1 Sample: Before WADT = 7.2g Post WADT = 5.2g

The mix ratio of the sample is approximately 27.78 % moderately hydraulic quicklime to 72.22 % aggregate (by weight). Approximately 1 Part Lime to 3 Parts Aggregate by Weight.

The fines experienced a moderate water absorption rate, while fully intact sub-samples of mortar experienced fast water absorption rates when subjected to the water droplet test ¹. This fast water absorption rate within the intact sub-samples indicates an interconnected internal pore network that permits the fast and efficient absorption and transportation of moisture through the thickness of the mortar.

This sand has been preserved from a sieve mesh 4mm to 0.075 mm, with the highest percentage of aggregate having been retrieved from sieve mesh size 0.75mm with 53.7% by weight. The mortar is very ungraded. Once dried, the mortar was found to be 10YR 7/3 'very pale brown' to 10YR 6/6 'pale brownish Yellow' when assessed against the Munsell Soil Colour Charts.

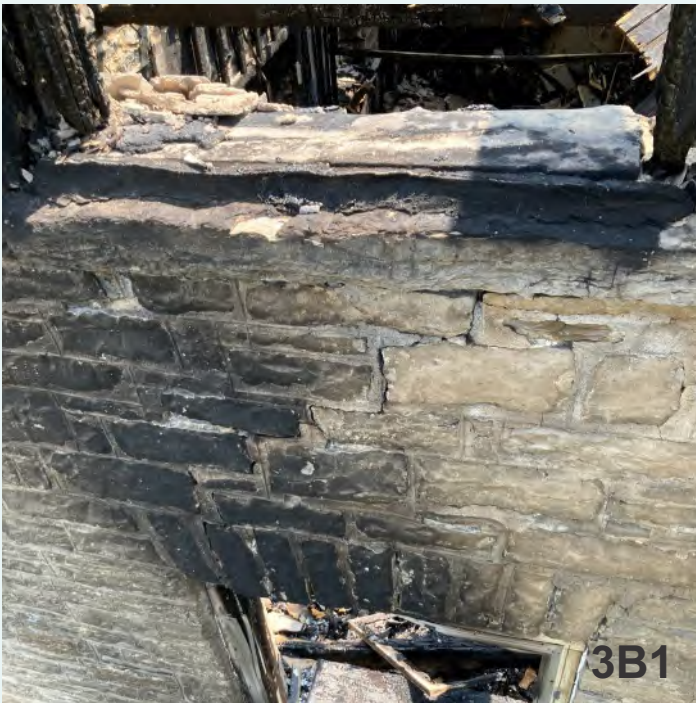
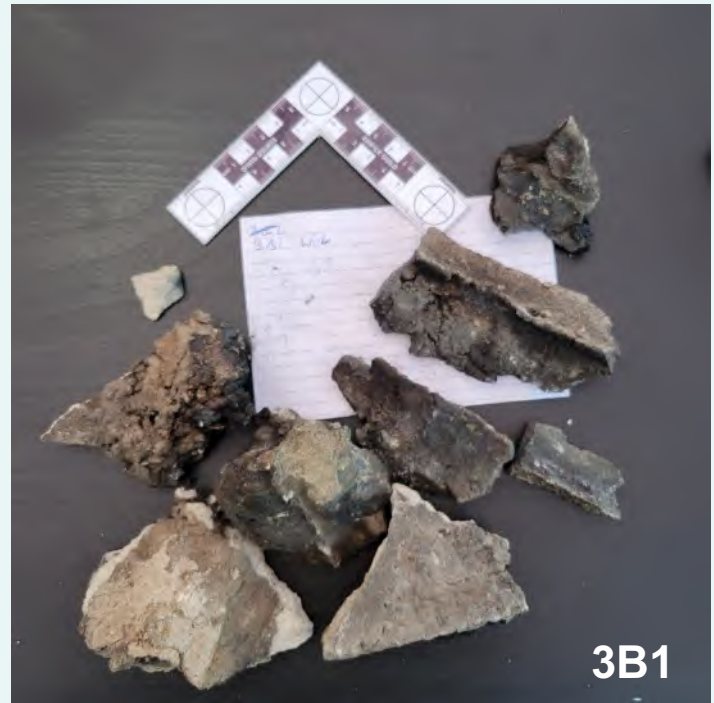
3B1 Sample: Before WADT = 9.3g Inconclusive Portland Cement

Natural colour Portland cement surface repair pointing on both buildings. Portland cement repair pointing on the 1868 Goulds Mills building and the 1886 Red Brick Italianate Structure. These samples were tested to ascertain the composition of the mortar samples taken. They were found to be 1:3 (1 Portland, 3 Sand). As this mortar does not make up any of the “Original” bedding or head mortar material and only used as a surficial repair solution in antiquity (c1950s) further testing is not required. Notwithstanding this, this type of mortar with Portland Cement should never be used on these buildings in any amount.

Again, this re-pointing is not an integral part of the make up of the two structures in question, and the Wet Acid Digestion Test obtained inconclusive results in exacting measurement of Portland Cement to Aggregate we can only provide a result of standard mixes during that time period and microscopic observation. Further testing with an electron microscope can be made, mapping and charting the grains of cement to aggregate. However, this mortar has no effect on the existing structures whatsoever, other than the possibility of a negative effect on spalling both stone and brick due to its (mortar) inability to be permeable.

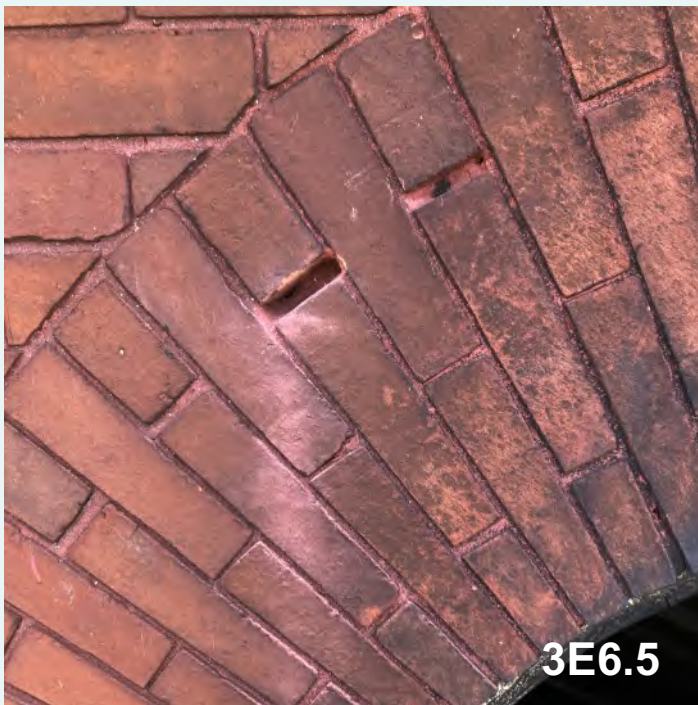
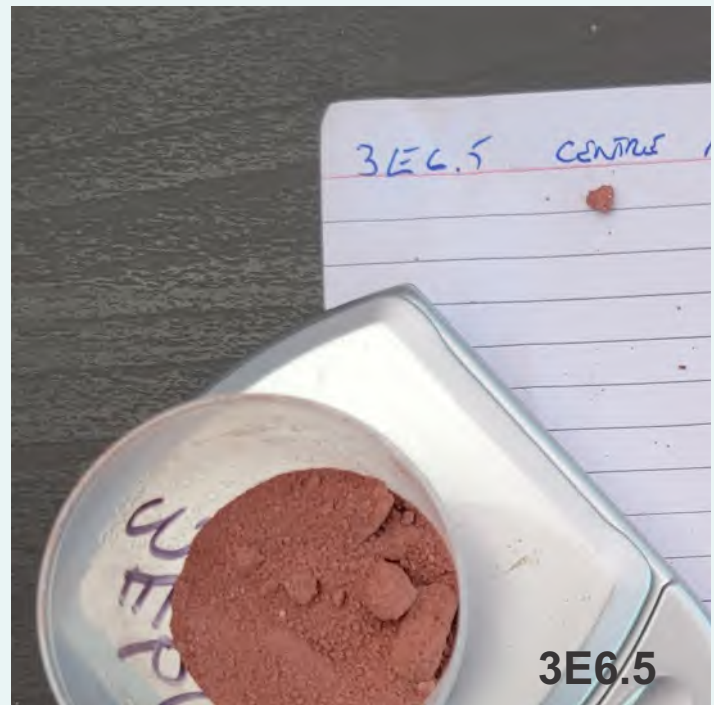
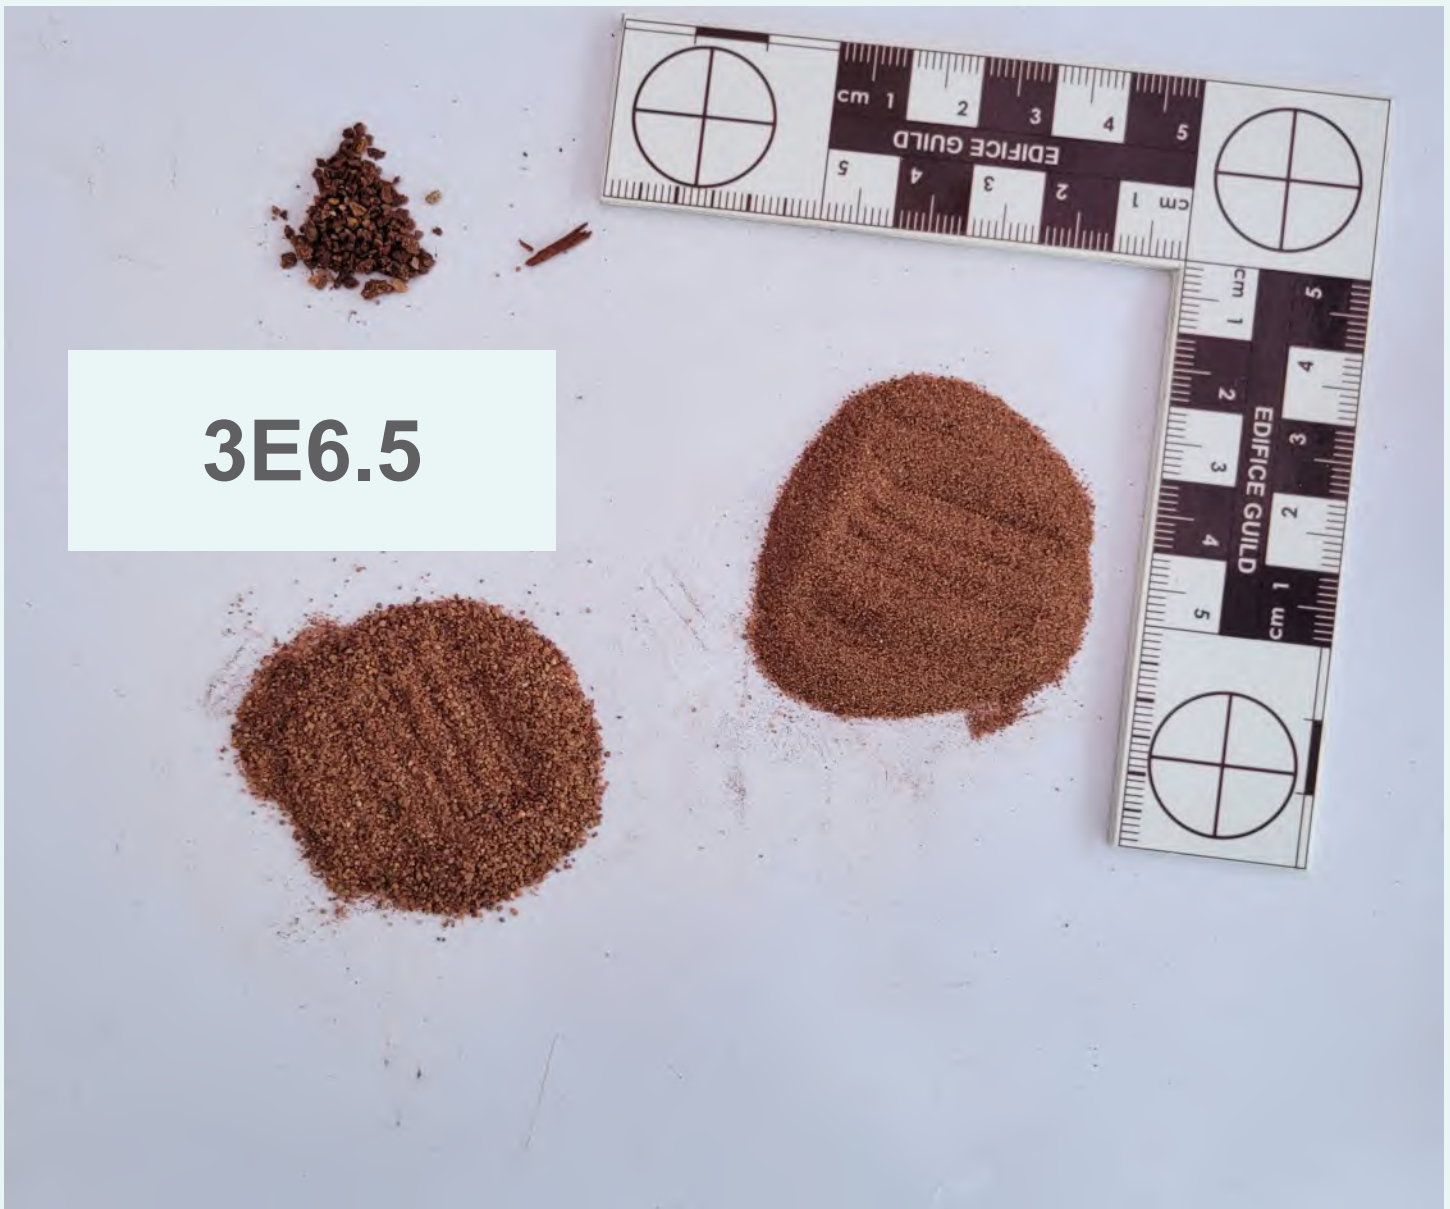
3E6.5 Sample Red: Before WADT = 12.2g Post WADT = 9.7g

The mix ratio of the sample is approximately 20.50% moderately hydraulic quicklime to 79.50% aggregate (by weight). Approximately 1 Part Lime to 3.25 Parts Aggregate by Weight. As the colourant is red iron oxide the weight can be skewed.

The fines experienced a moderate water absorption rate, while fully intact sub-samples of mortar experienced extremely fast water absorption rates when subjected to the water droplet test. This fast water absorption rate within the intact sub-samples indicates an interconnected internal pore network that permits the fast and efficient absorption and transportation of moisture through the thickness of the mortar.

This sand has been preserved from a sieve mesh 4mm to 0.075 mm, with the highest percentage of aggregate having been retrieved from sieve mesh size 0.75mm with 48.1% by weight. The Munsell Soil Colour Charts could not be used on this sample due to the red iron oxide colouring of the mortar. This appears to be the same vernacular aggregate as the 1868 portion, simply well graded and sieved prior to mixing.

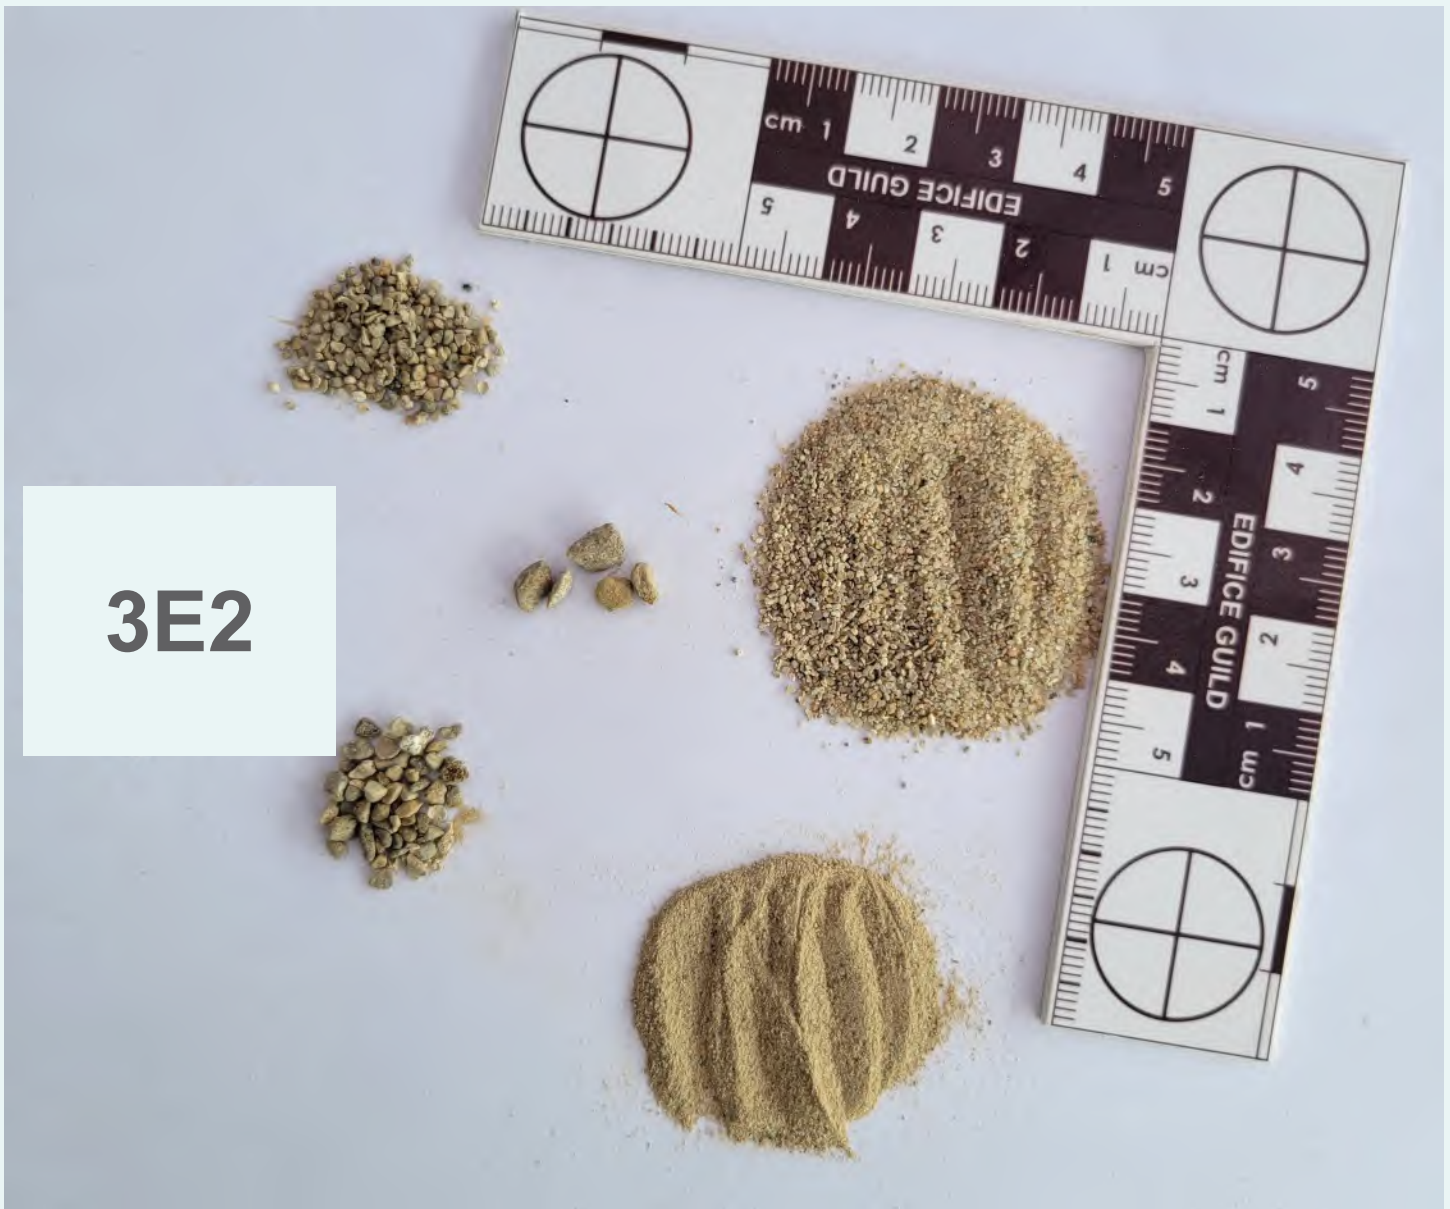
3E2

The fines experienced a moderate water absorption rate, while fully intact sub-samples of mortar experienced fast water absorption rates when subjected to the water droplet test. This fast water absorption rate within the intact sub-samples indicates an interconnected internal pore network that permits the fast and efficient absorption and transportation of moisture through the thickness of the mortar.

This sand has been preserved from a sieve mesh 4mm to 0.075 mm, with the highest percentage of aggregate having been retrieved from sieve mesh size 0.75mm with 51.5% by weight. The mortar is very ungraded. Once dried, the mortar was found to be 10YR 7/3 'very pale brown' to 10YR 6/6 'pale brownish Yellow' when assessed against the Munsell Soil Colour Charts.

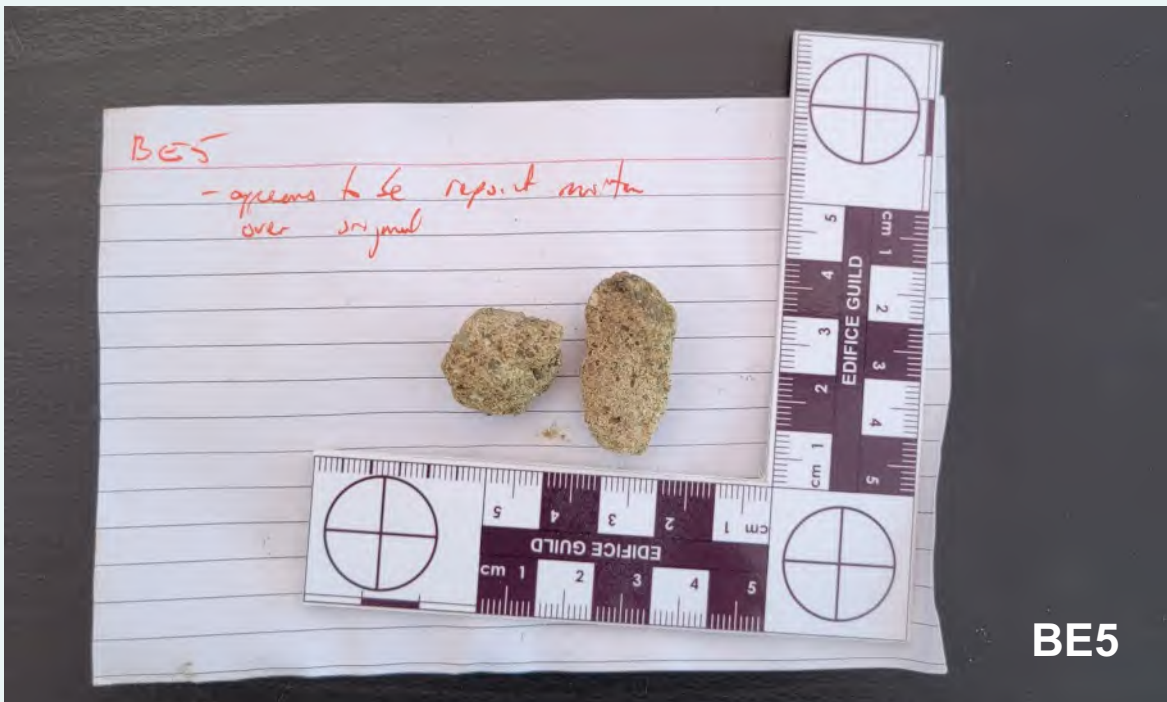
BE5 Sample Lime: Before WADT = 11.4g Post WADT = 8.5g

The mix ratio of the sample is approximately 25.44 % moderately hydraulic quicklime to 74.56 % aggregate (by weight). Approximately 1 Part Lime to 3 Parts Aggregate by Weight.

The fines experienced a moderate water absorption rate, while fully intact sub-samples of mortar experienced fast water absorption rates when subjected to the water droplet test. This fast water absorption rate within the intact sub-samples indicates an interconnected internal pore network that permits the fast and efficient absorption and transportation of moisture through the thickness of the mortar.

This sand has been preserved from a sieve mesh 4mm to 0.075 mm, with the highest percentage of aggregate having been retrieved from sieve mesh size 0.75mm with 51.5% by weight. The mortar is very ungraded. Once dried, the mortar was found to be 10YR 7/3 'very pale brown' to 10YR 6/6 'pale brownish Yellow' when assessed against the Munsell Soil Colour Charts.

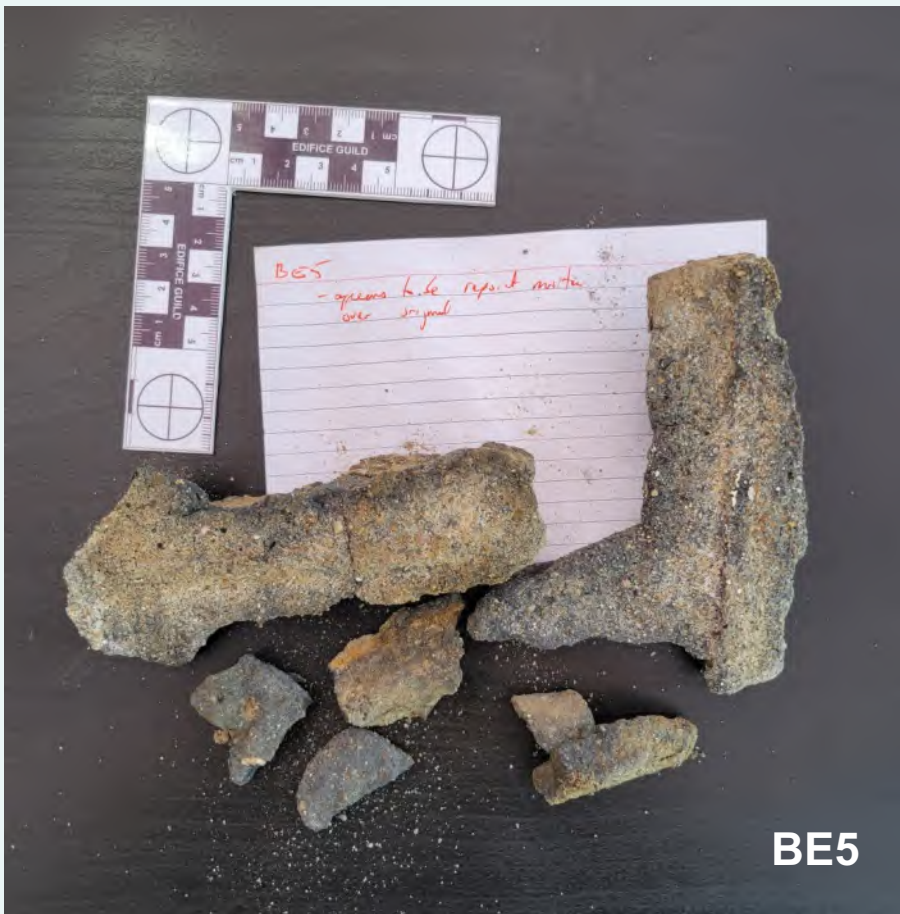
BE5 Sample Black: Before WADT = 15.15g Inconclusive Portland Cement

Black (pigmented) strap Portland cement repair pointing on the 1868 Goulds Mills building. These samples were tested to ascertain the composition of the mortar samples taken. They were found (an approximation through magnification) to be 1:1:2 (1 Lime, 1 Portland, 2 Sand). As this mortar does not make up any of the “Original” bedding or head mortar material and only used as a surficial repair solution in antiquity (c1930s) further testing is not required.

As this re-pointing is not an integral part of the make up of the two structures in question, and the Wet Acid Digestion Test obtained inconclusive results in exacting measurement of Portland Cement, Aggregate and Lime we can only provide a result of standard mixes during that time period and microscopic observation. Further testing with an electron microscope can be made, mapping and charting the grains of cement to aggregate. However, this mortar has no effect on the existing structures whatsoever, other than the possibility of a negative effect on spalling both stone and brick due to its (the mortar) inability to be permeable.

Notwithstanding this, this type of mortar with a Portland Cement content should never be used on these buildings in any amount.

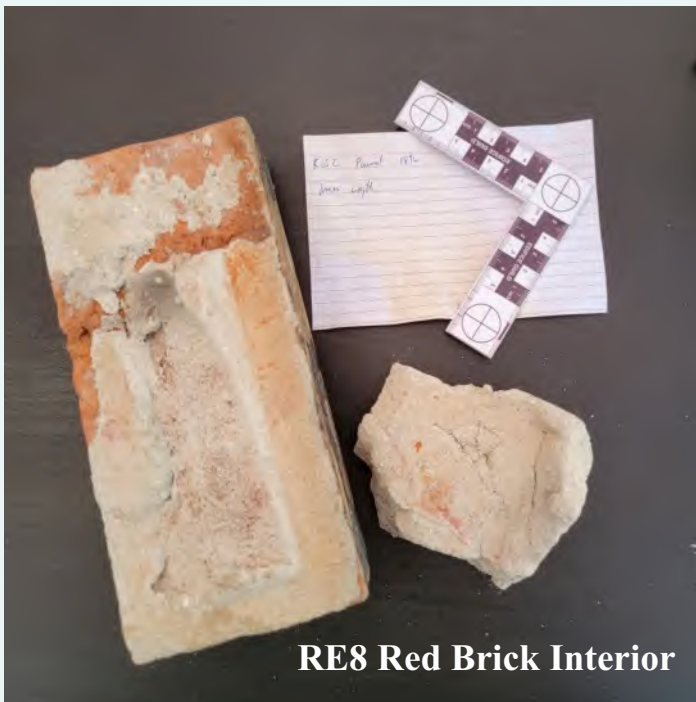
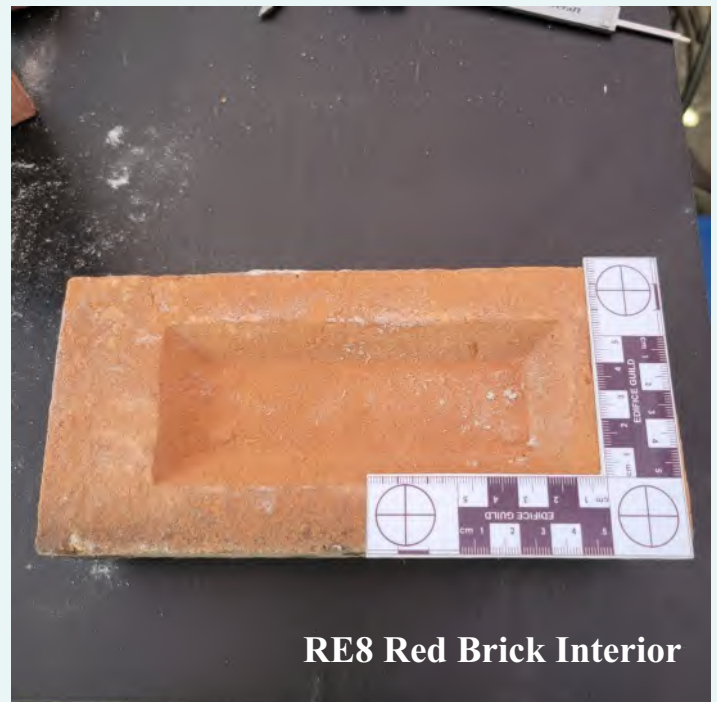
RE8 Red Brick Interior

Half Brick Compressive Strength Wet = 11.996 MPa

Half Brick Compressive Strength Dry = 14.547 MPa

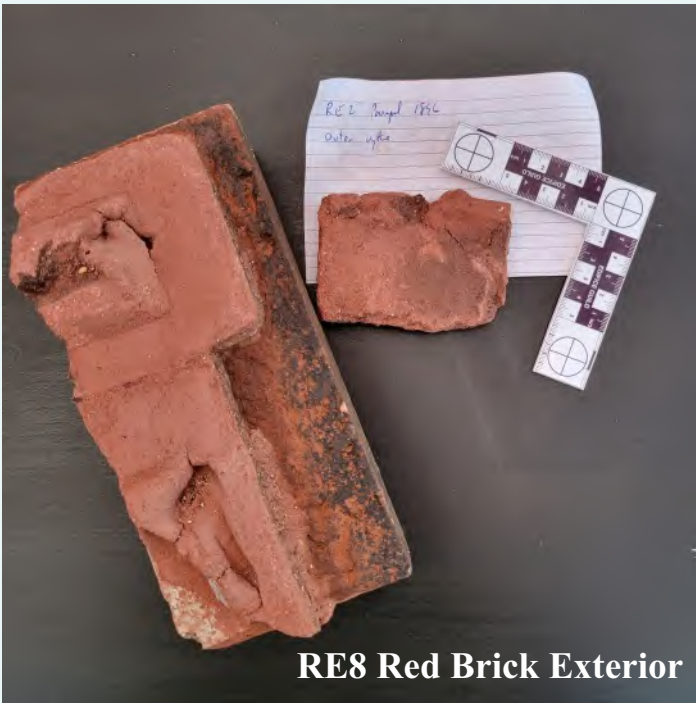
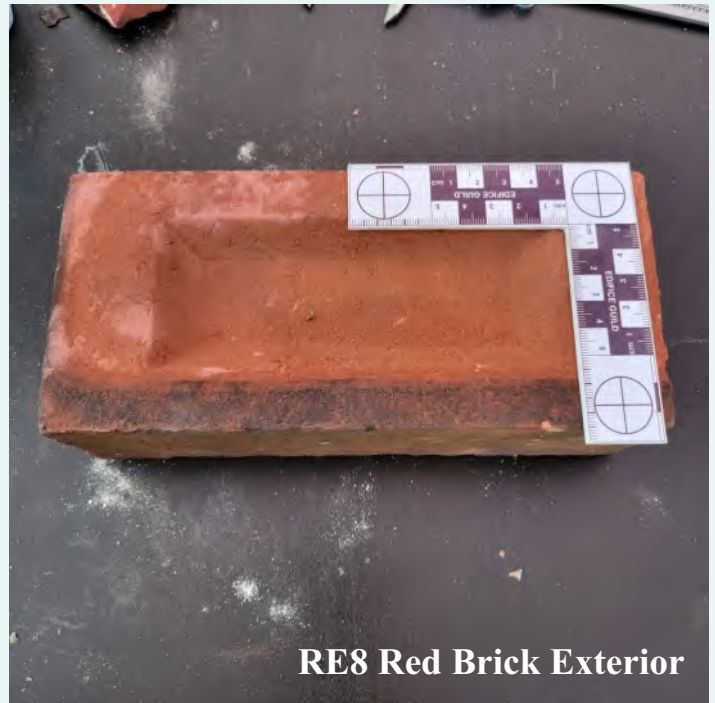
RE8 Red Brick Exterior

Half Brick Compressive Strength Wet = 12.785 MPa

Half Brick Compressive Strength Dry = 15.207 MPa

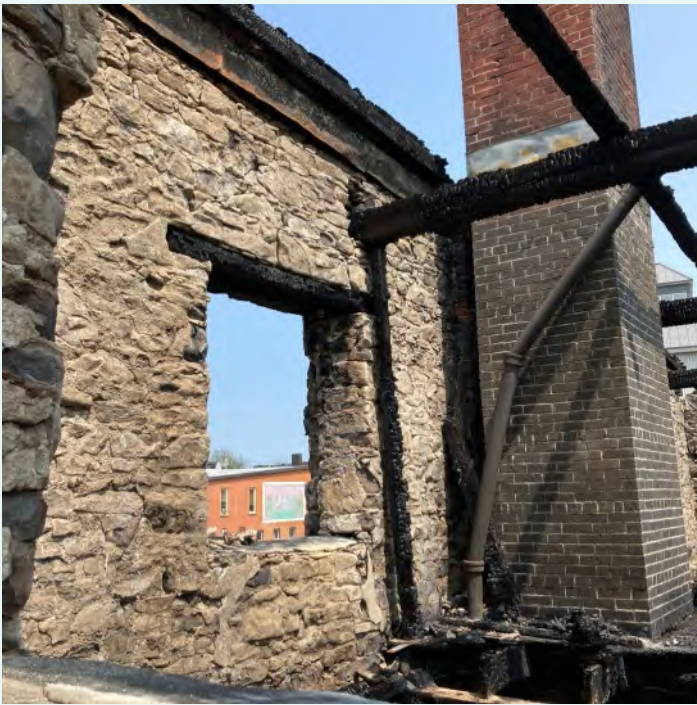
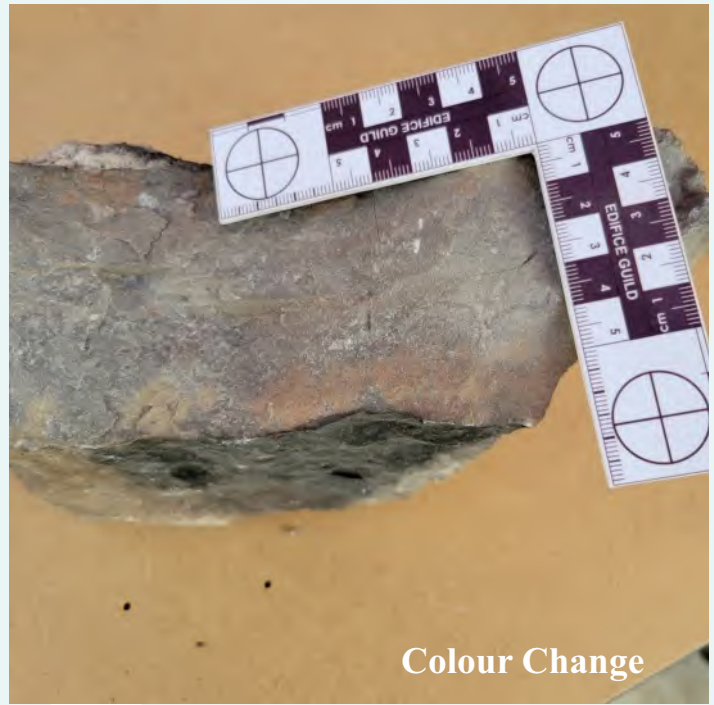
Nepean Sandstone

Quoted Research: ² “The colour change in sandstones corresponds with the dehydration of iron compounds, as noted in the samples provided. This requires a temperature of 250-300 °C. Brown or buff coloured sandstone changes colour to reddish brown but the change may not be apparent until the stone has been heated to temperatures above 400 °C. This colour change can persist after heating to 1000 °C.”

² “Heating sandstones to greater than 573 °C usually causes internal rupturing of the quartz grains thus leading to weakening of the stone which tends to become friable.”

In the samples provided we did not find this to be the case (not able to crumble the samples by hand), the stone would only successfully fracture with a 2-pound mash hammer.

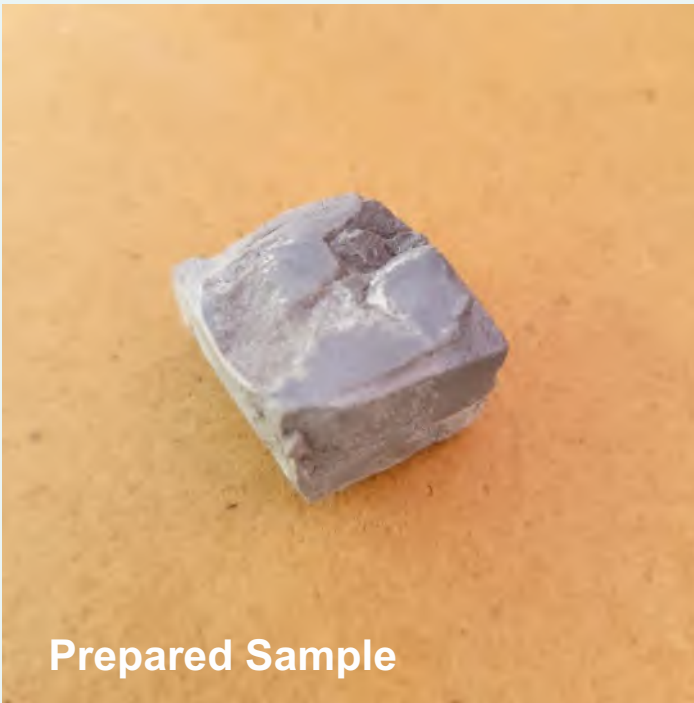
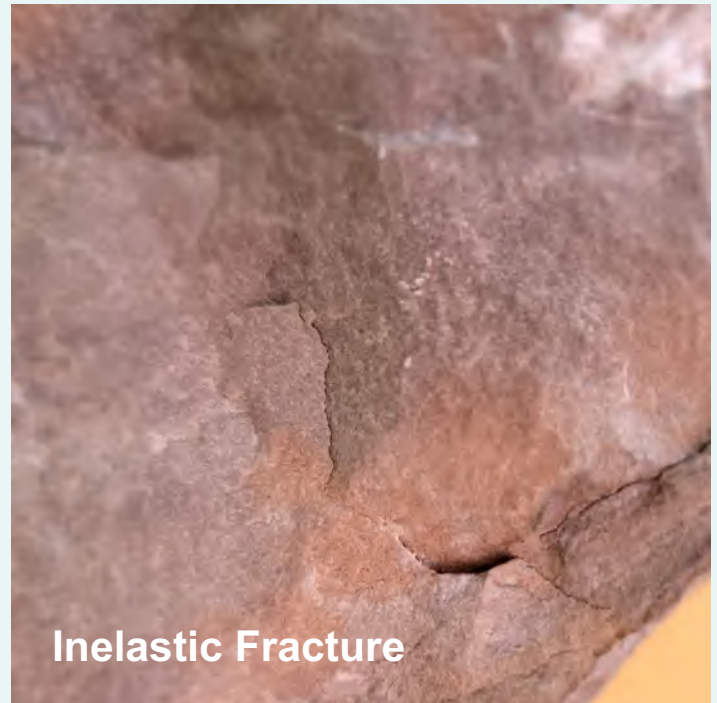
Sandstone Sample:

*¹ **Crack formed** (inelastic fracture)

*² **Flexural Strength** = 9.376 MPa (inelastic fracture)
