SMITHS FALLS
RISE AT THE FALLS

G. Douglas Vallee Limited

Heritage Building Structural Pathology Engineering Report

25 Old Mill Road
Town of Smiths Falls

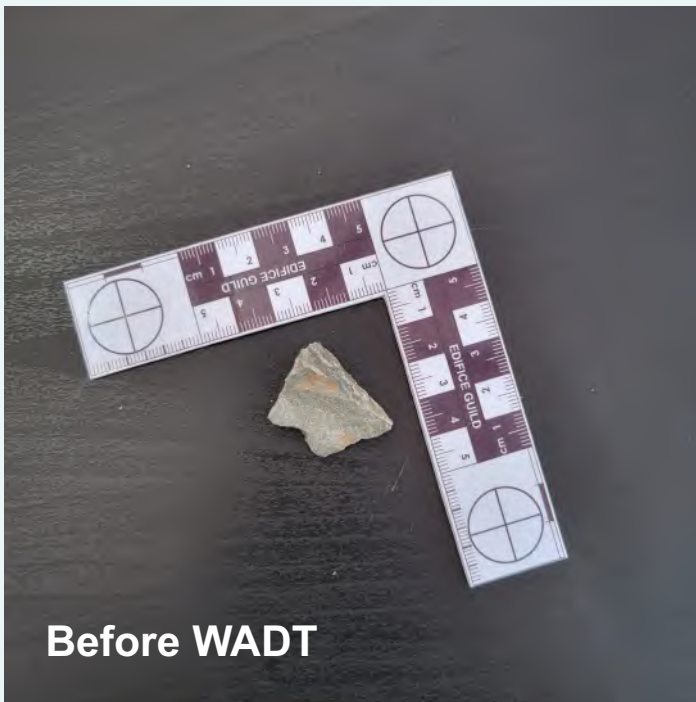
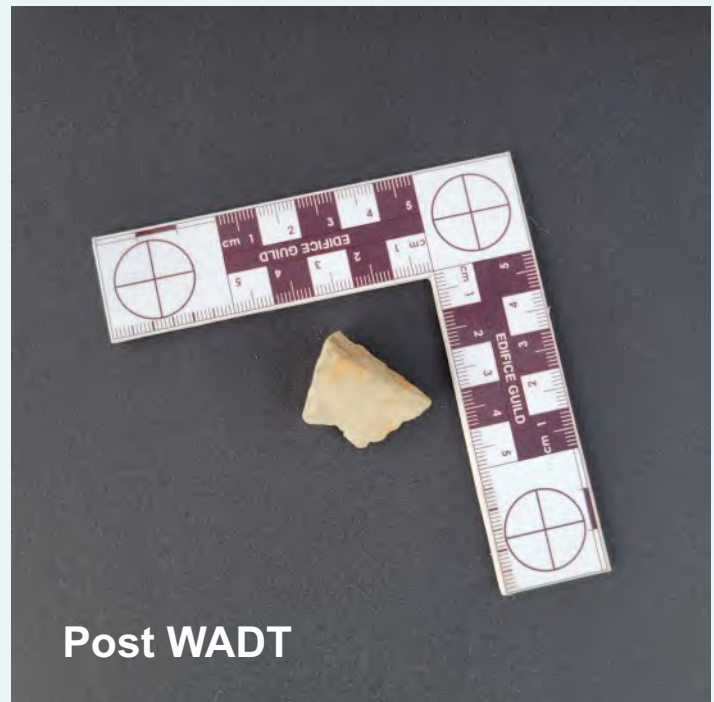
Wet Acid Digestion Test on Sandstone Sample:

A Wet Acid Digestion Test was performed on a small 12.1 g (as weighed) sample of sandstone collected from the building at RC5. The sample was subjected to a Wet Acid Digestion Test utilizing 45% acetic acid for 48 hours. The sample was dried and weighed. The resulting weight was 11.80 g which is to be expected from sandstone. The 0.30 g difference can be attributed to surface fines, which were present in the specimen receptacle. Therefore, all samples provide by VALLEE from the 1868 Goulds Mills building appear to be Sandstone.

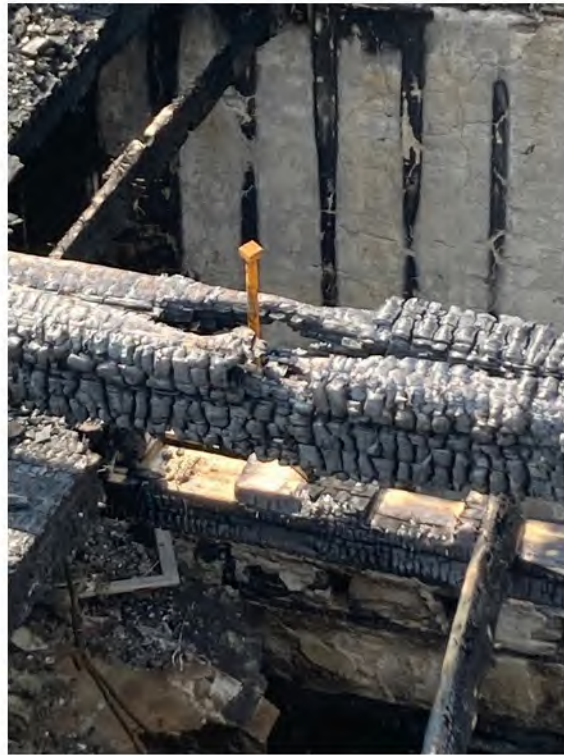
RC2 spike in timber

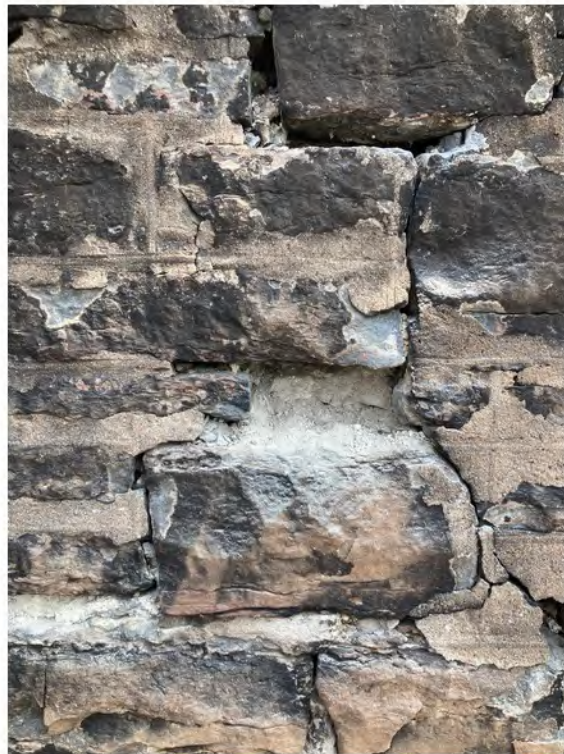
RE2 mortar powder

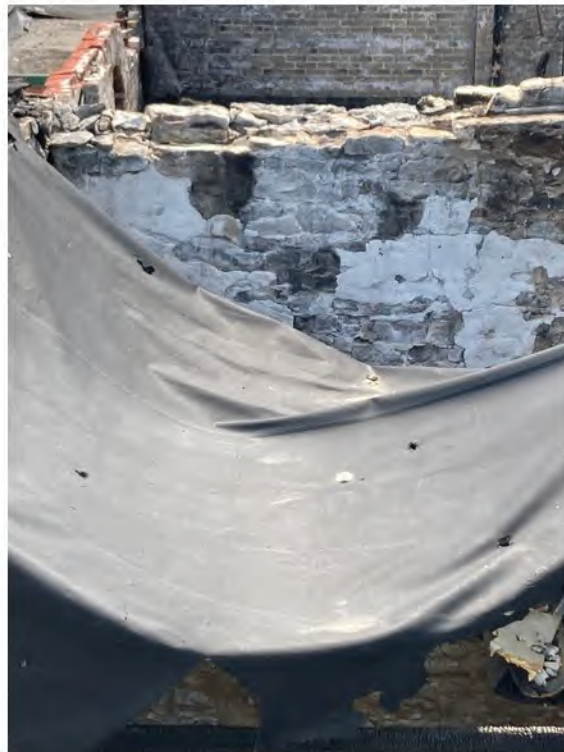
3A5-3B5 parging

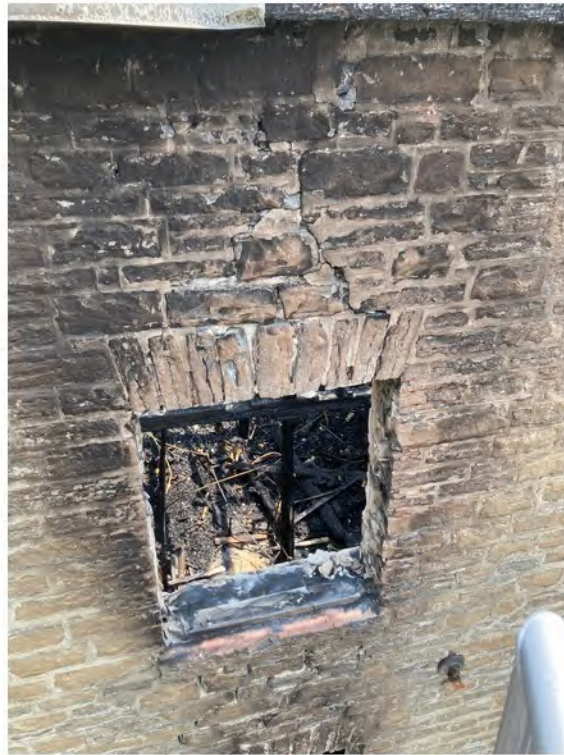
3E2 above 2E2 below

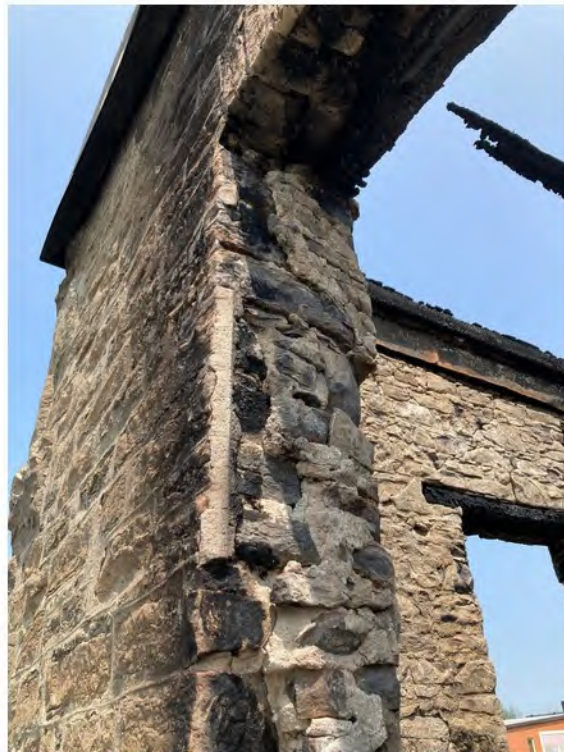
3E2 exterior

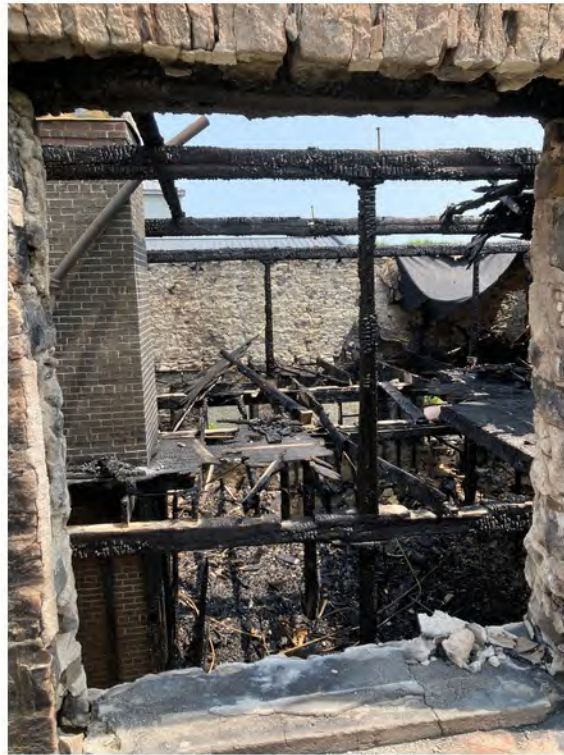
3E2 jamb wall section

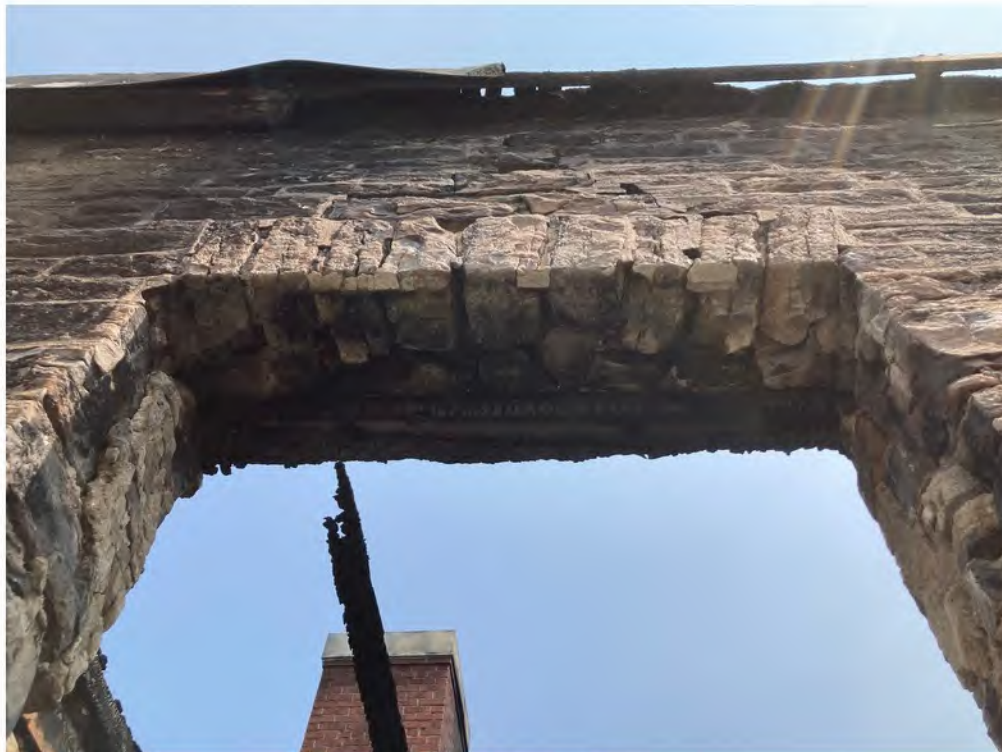
3E2 view inside window

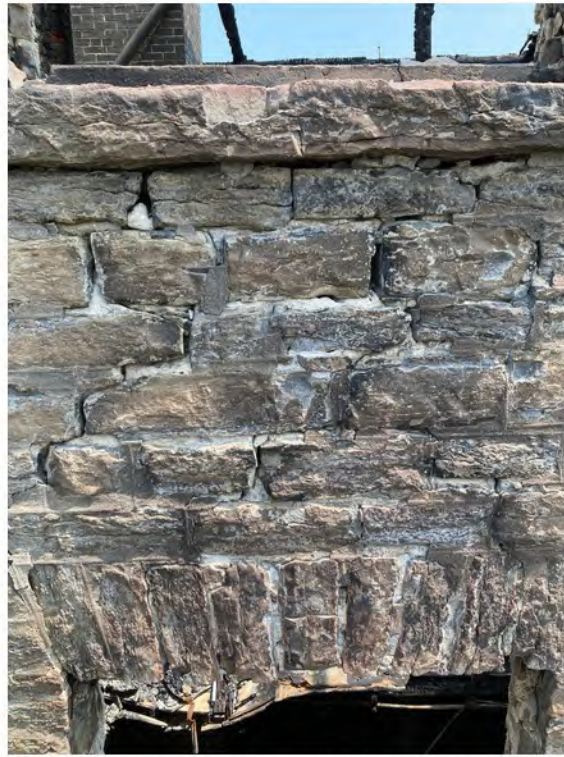
3E2 voussoir lintel section

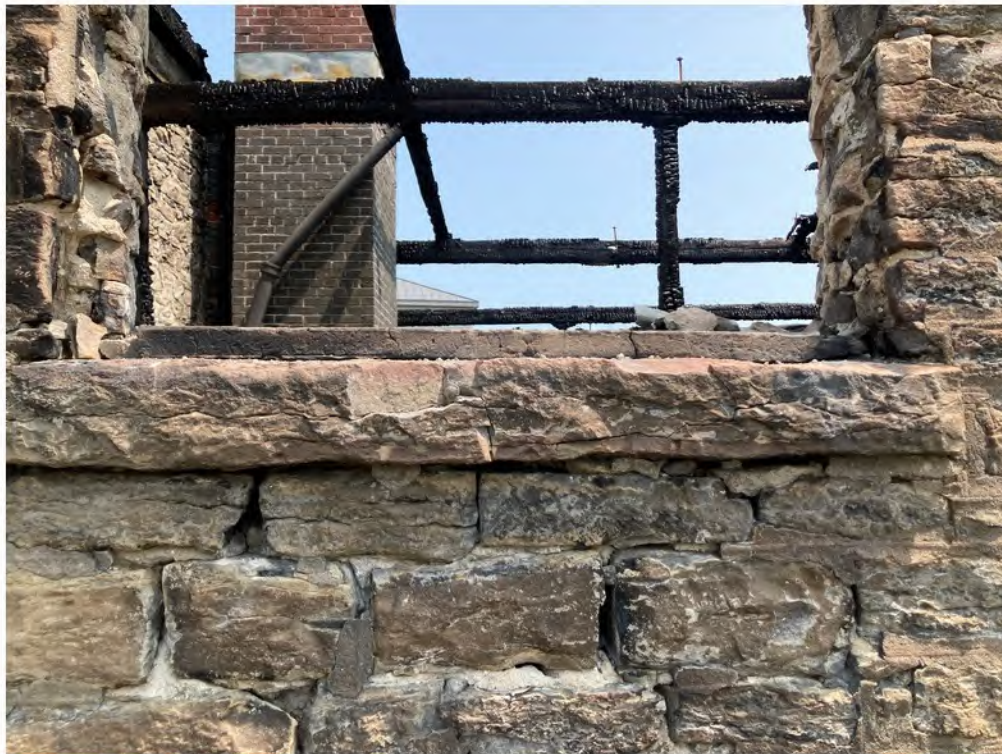
3E2 window sill @E2 voussoir

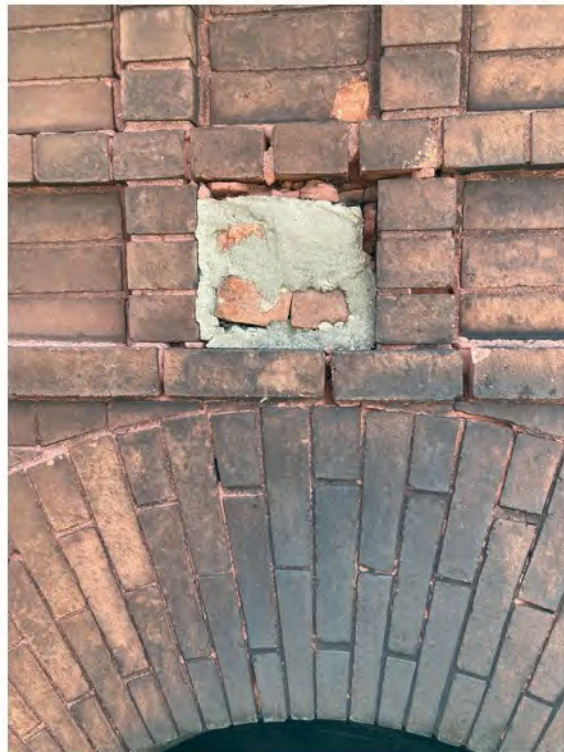
3E6.5 red brick mortar sample locn

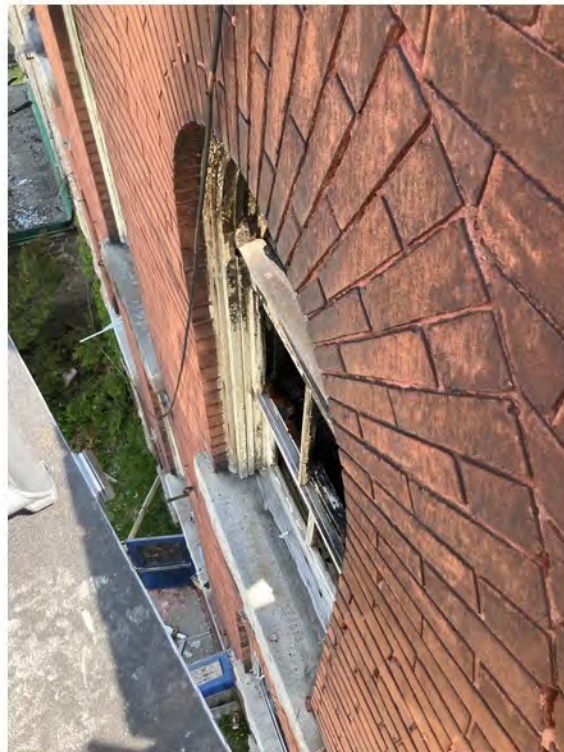
3E6.5 window frame supporting failed roof beam

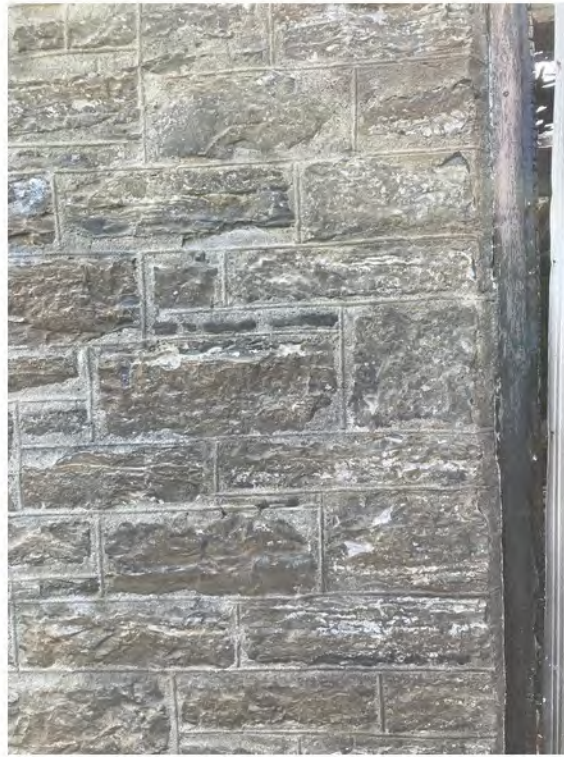
2D1 exterior good condition

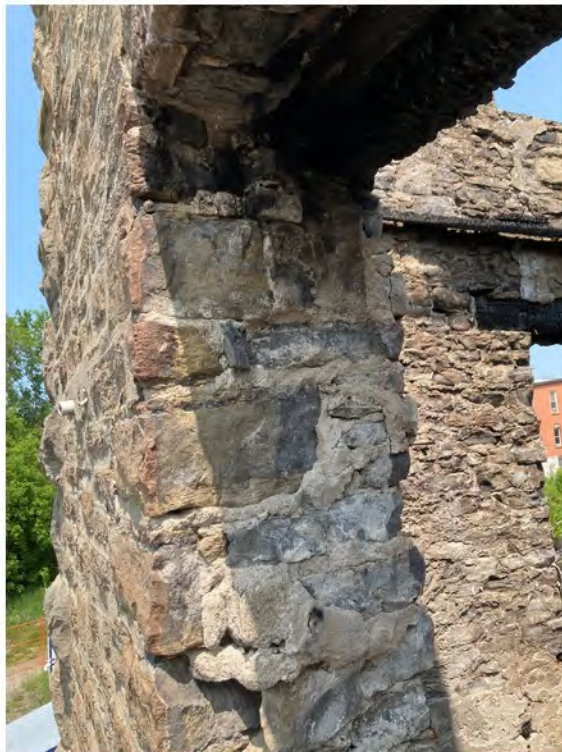
2E2 pyramidal cracking

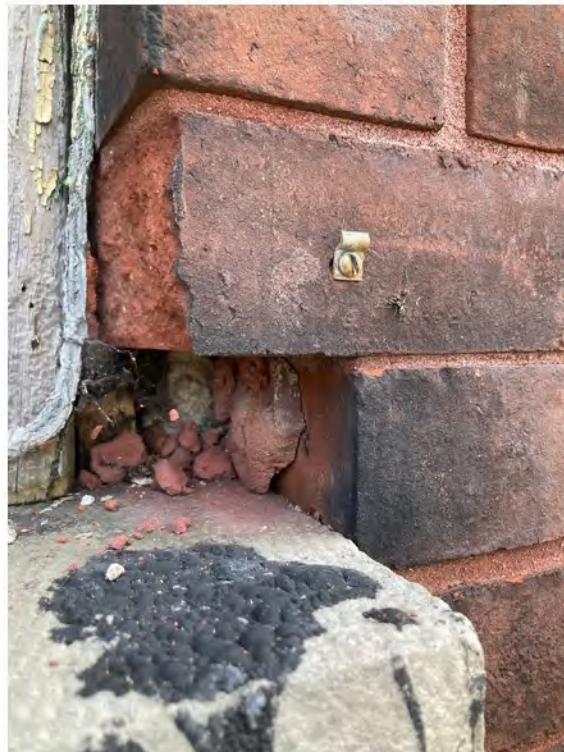
2E7 brick sample locn

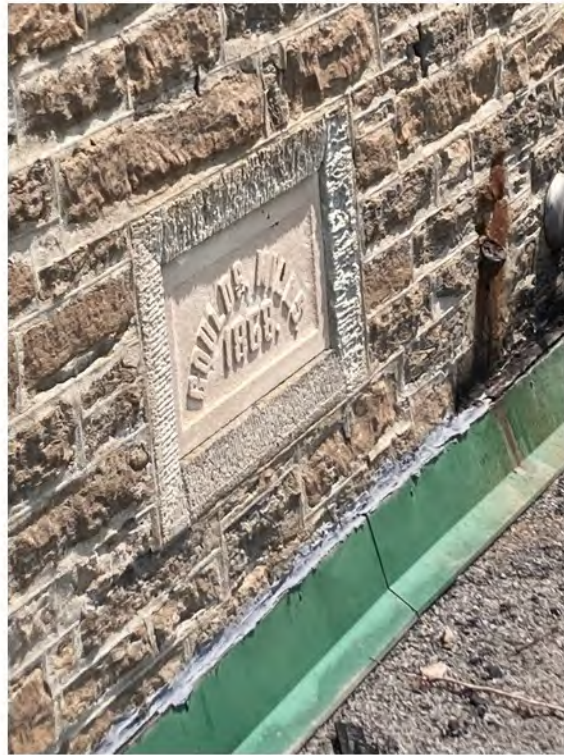
2E7 mortar sample locn

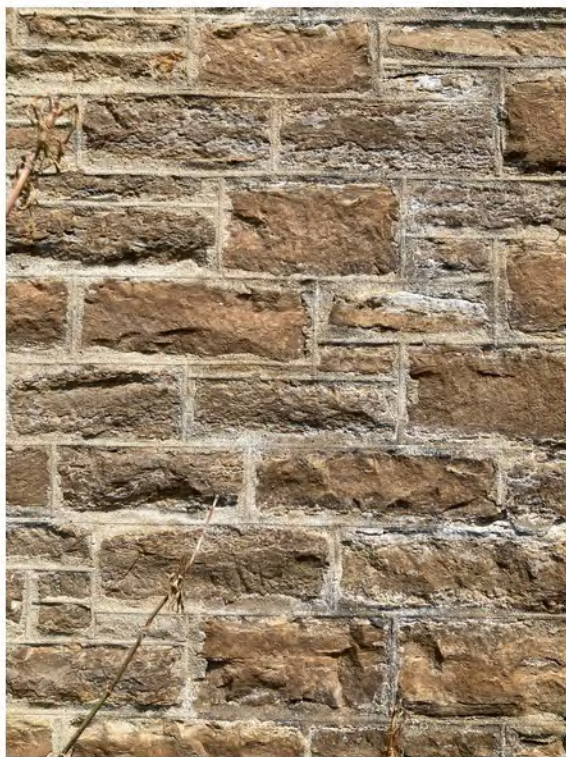
MB1 window voussoir Spalled lintel stone sample locn

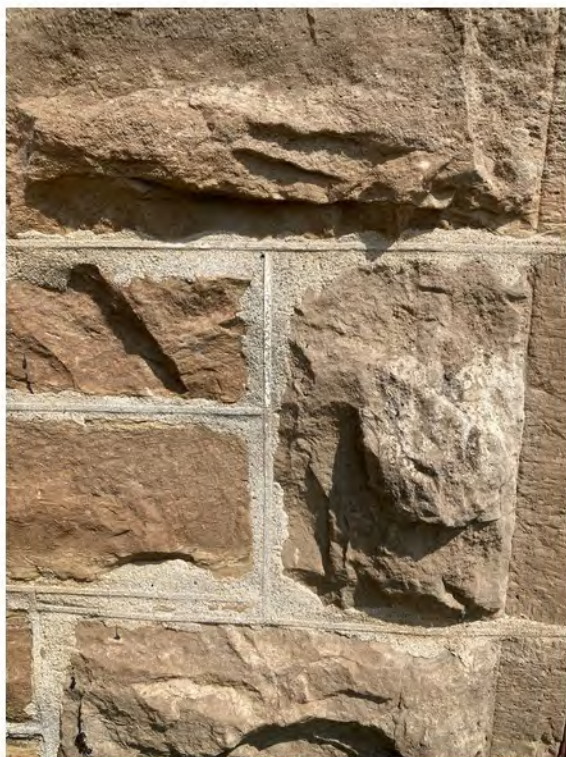
ME5 exterior Sample loch
